## **Test report # PF21006-A**

**Issued to: Intex International**

**Fire resistance tests for wall penetrations**

**Test method: AS 1530.4:2014**

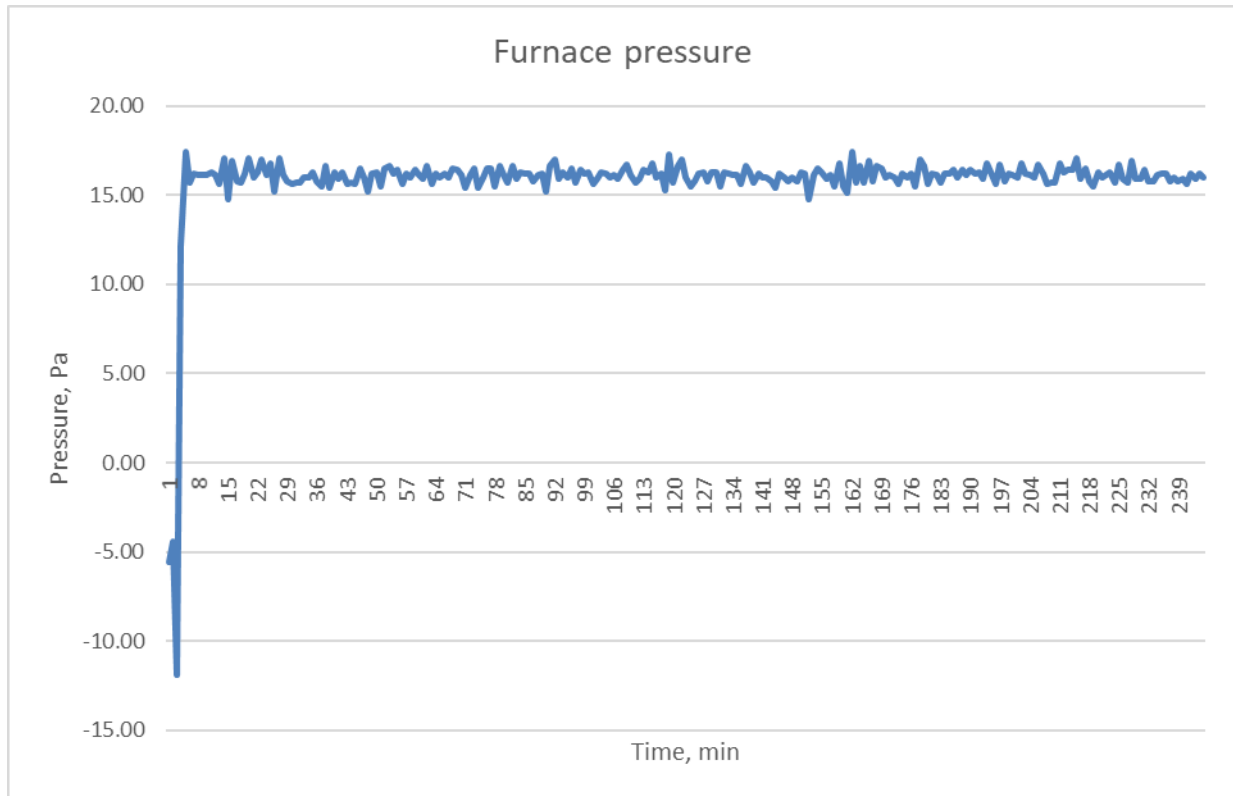
## 6.3 Pressure Readings

After the first 5 minutes of the test, the furnace pressure was maintained at  $16 \pm 3$  Pa with respect to atmosphere. The probe was located 500mm above the furnace floor.

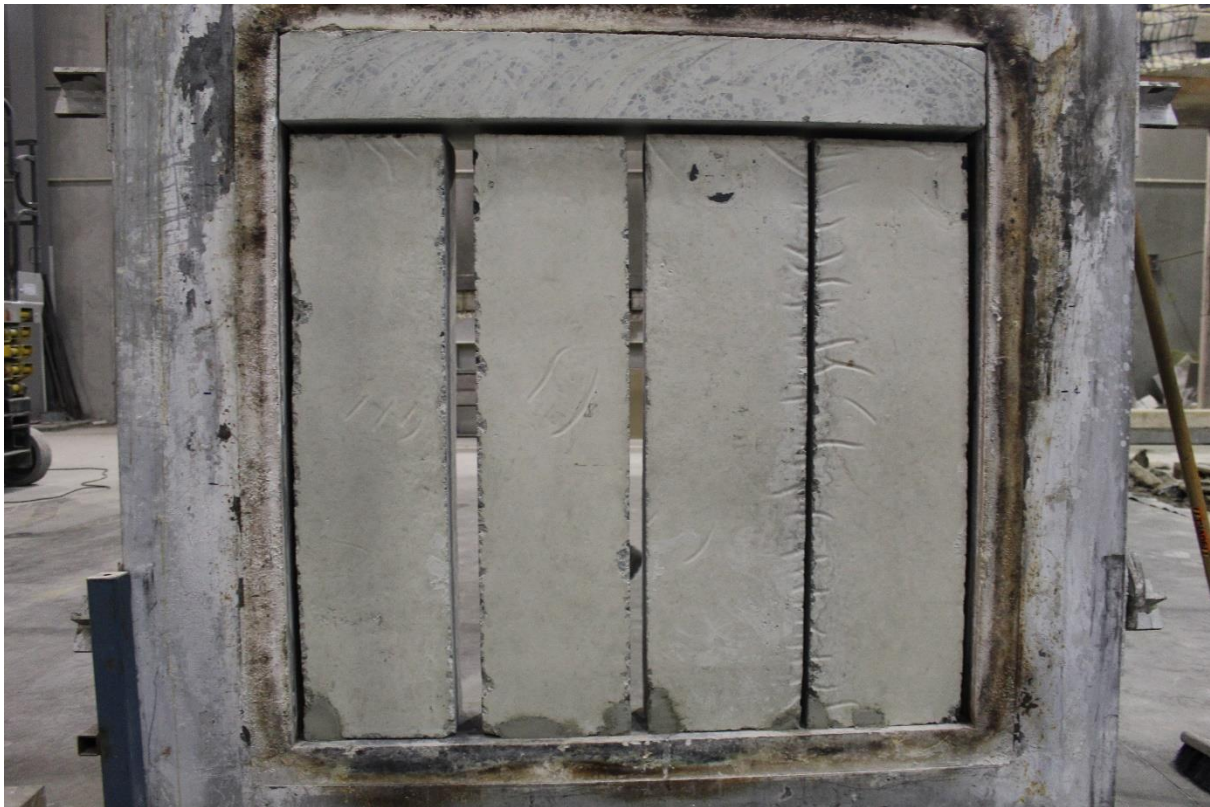
Separating element (exposed face)

Concrete Slab (1.3) was fixed to the top of the refractory frame, then steel angle (1.4) was fixed to the concrete slab and bottom of the refractory frame. Concrete Slab (1.2) was cut into 4 slabs with a width of 285mm, 270mm, 260mm and 260mm. The cut concrete slabs were placed in the refractory frame and fixed to the steel angle using screw anchors (4.1). The horizontal spacing between concrete slabs was measured to be 10mm, 30mm and 50mm. The vertical spacing between the concrete slabs (1.2 and 1.3) was 20mm.

Performance of the separating element – Maximum temperature of the separating element measured during the test 130mm from any joint was 161 degC at 244 minutes.
