Test report # PF21007-A

Issued to: Intex International

Fire resistance tests for wall penetrations

Test method: AS 1530.4:2014

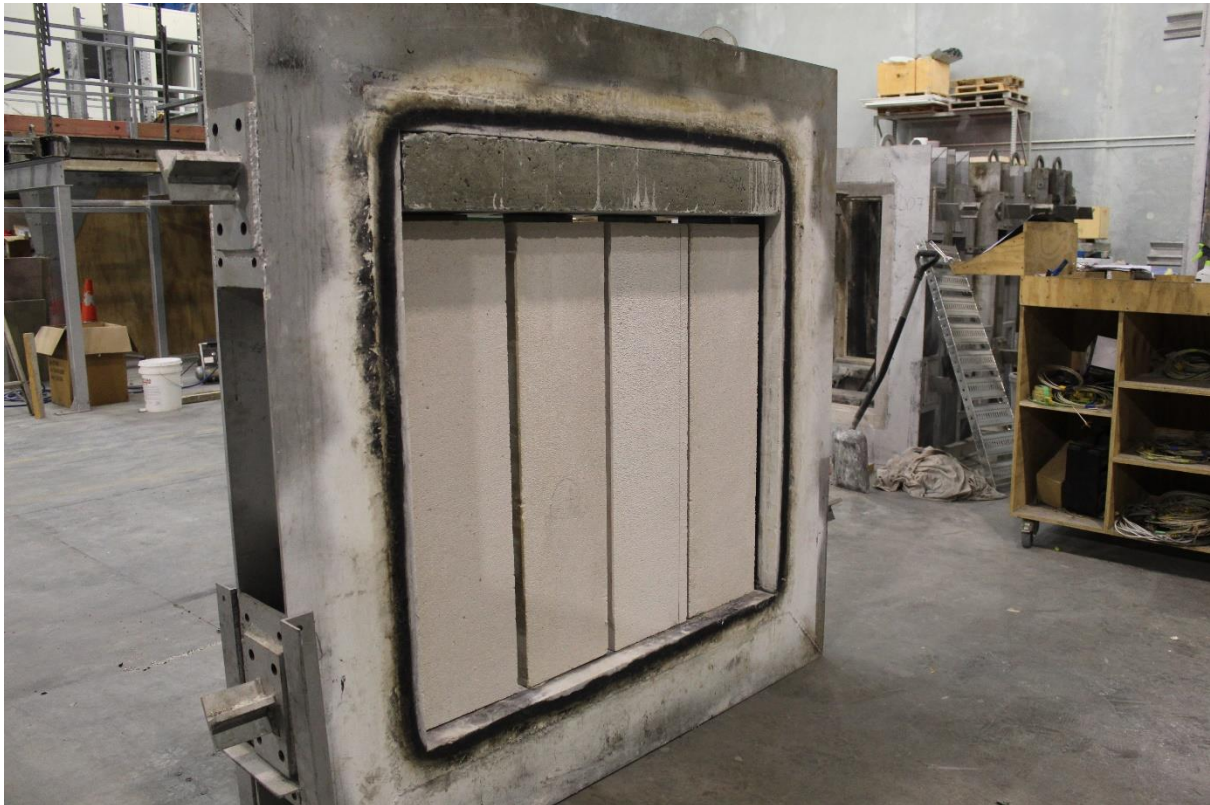
Separating element (exposed face)

Concrete Slab (1.3) was fixed to the top of the refractory frame, then steel angle (1.4) was fixed to the concrete slab and bottom of the refractory frame. Hebel panels (1.2) were cut to a width of 285mm, 275mm, 260mm and 270mm. Hebel panels were placed in the refractory frame and fixed to the steel angle using screw anchors (4.1). The spacing between Hebel panels was measured to be 10mm, 20mm and 30mm. The spacing between Hebel panels and the concrete slab was 20mm.

Performance of the separating element – Maximum temperature of the separating element measured during the test 130mm from any joint was 143 degC at 125 minutes.

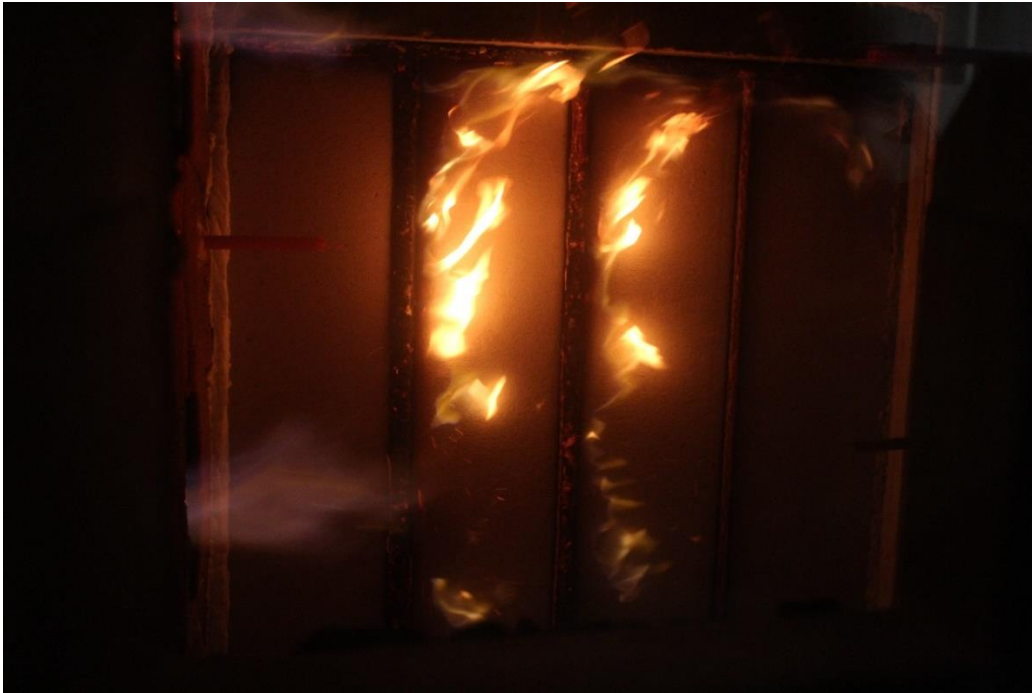
10 minutes:

Time Minutes	Test Face	SP#	Observations
5	E	B, C	Visible expansion of sealant, visible flakes falling from combusted areas.
10	E	A	Visible expansion of sealant with white discolouring
10	E	B, C	Visible combustion along entire specimen with flaking
15	E	B, C, D	Visible black discolouring/charring of sealant
15	E/U	ALL	No notable changes
20	U	D	Small amount of smoke coming from head junction near thermocouples TC31, TC32 and TC33
20	E	D	Visible gaps in head joint sealant
20	E	A, B	No notable changes
20	E	C	White discolouring of specimen
30	E	ALL	All visible sealant has white discolouring
30	U	B, C, D	Visible expansion of sealant within head joint above specimen B and C
45	U	D	Visible expansion of sealant within head joint above specimen A
45	E	C, D	Visible gaps in expanded sealant
60	E/U	ALL	No notable changes
72	U	SE	Visible cracks through right side (unexposed view) of separating element, with visible expansion of unexposed sealant
