Test report # PF21009-A

Fire resistance tests for wall penetrations

Test method: AS 1530.4:2014

Report Date 17/09/2021

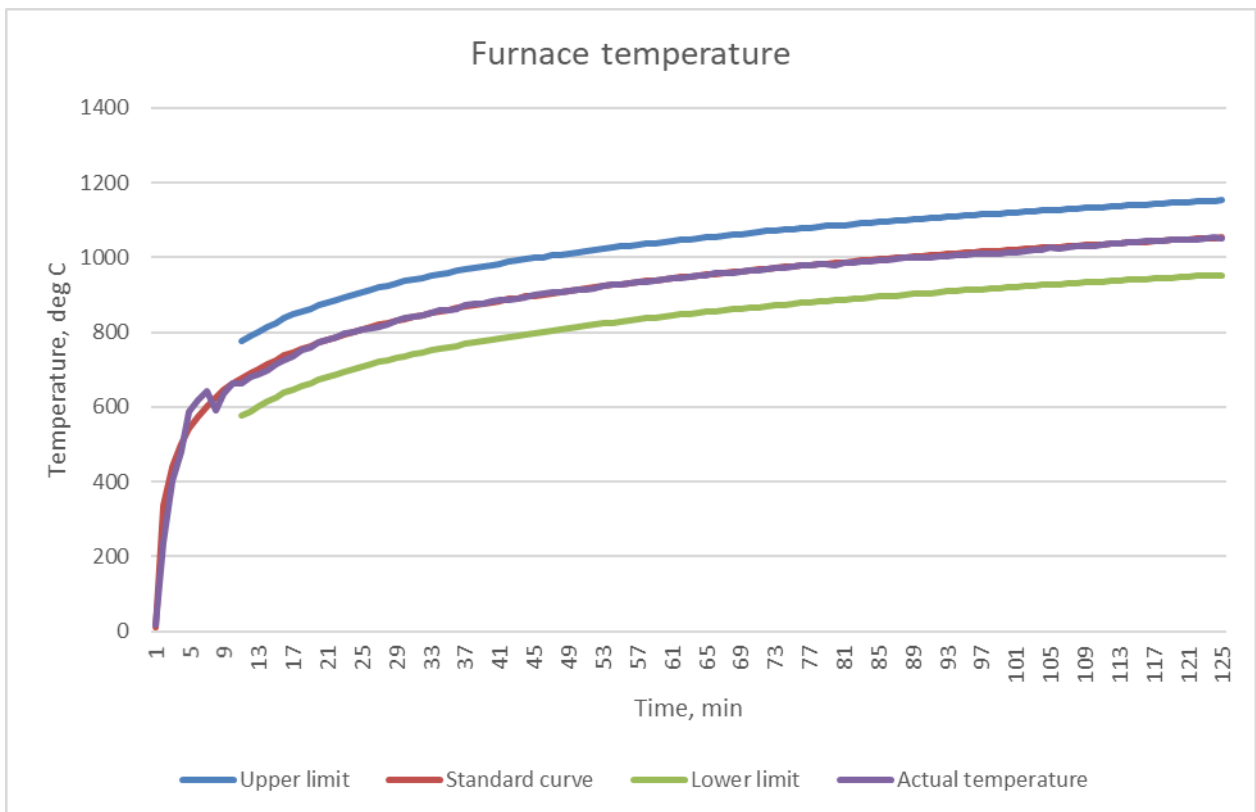
6.1 Furnace Temperature

The furnace was controlled to follow the temperature/time relationship specified in AS 1530.4-2014 as closely as possible.

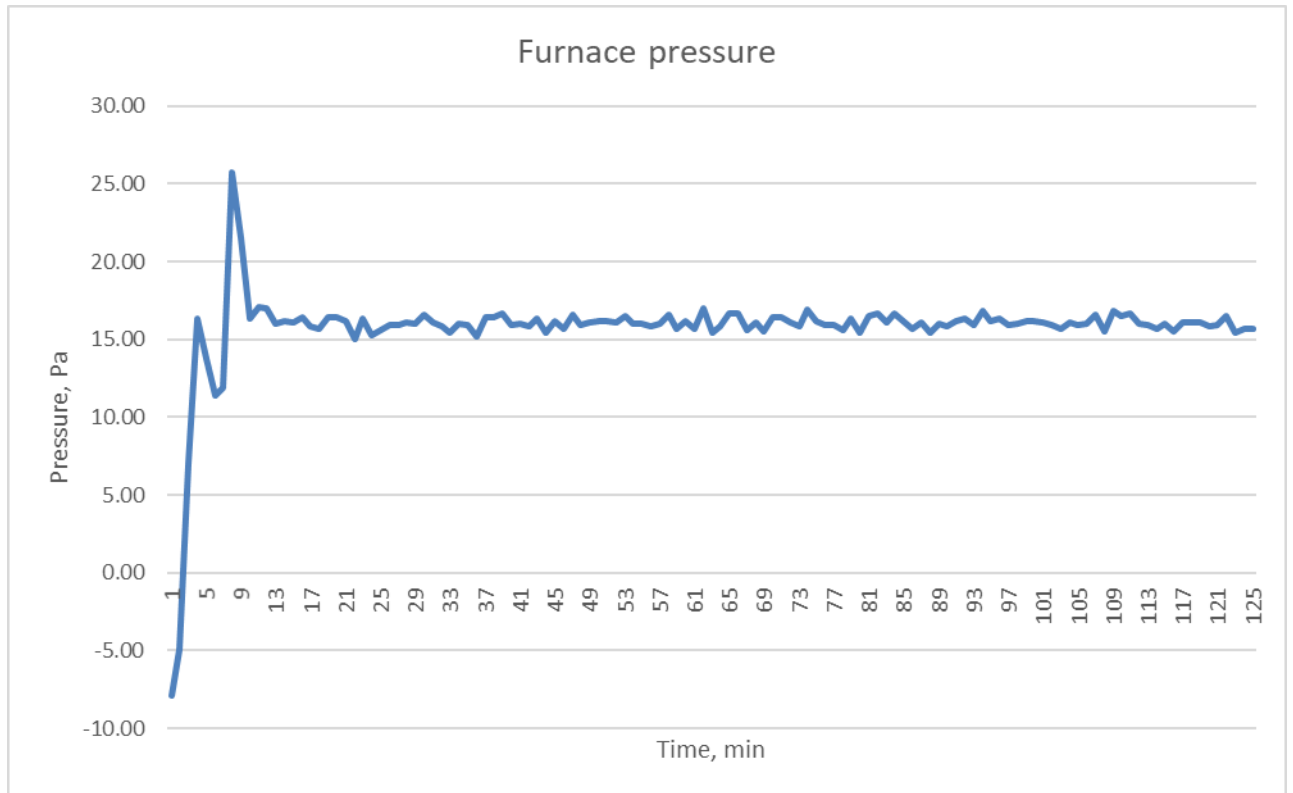
6.3 Pressure Readings

The furnace pressure was maintained at 16 ± 3 Pa with respect to atmosphere. The probe was located 500mm above the furnace floor.

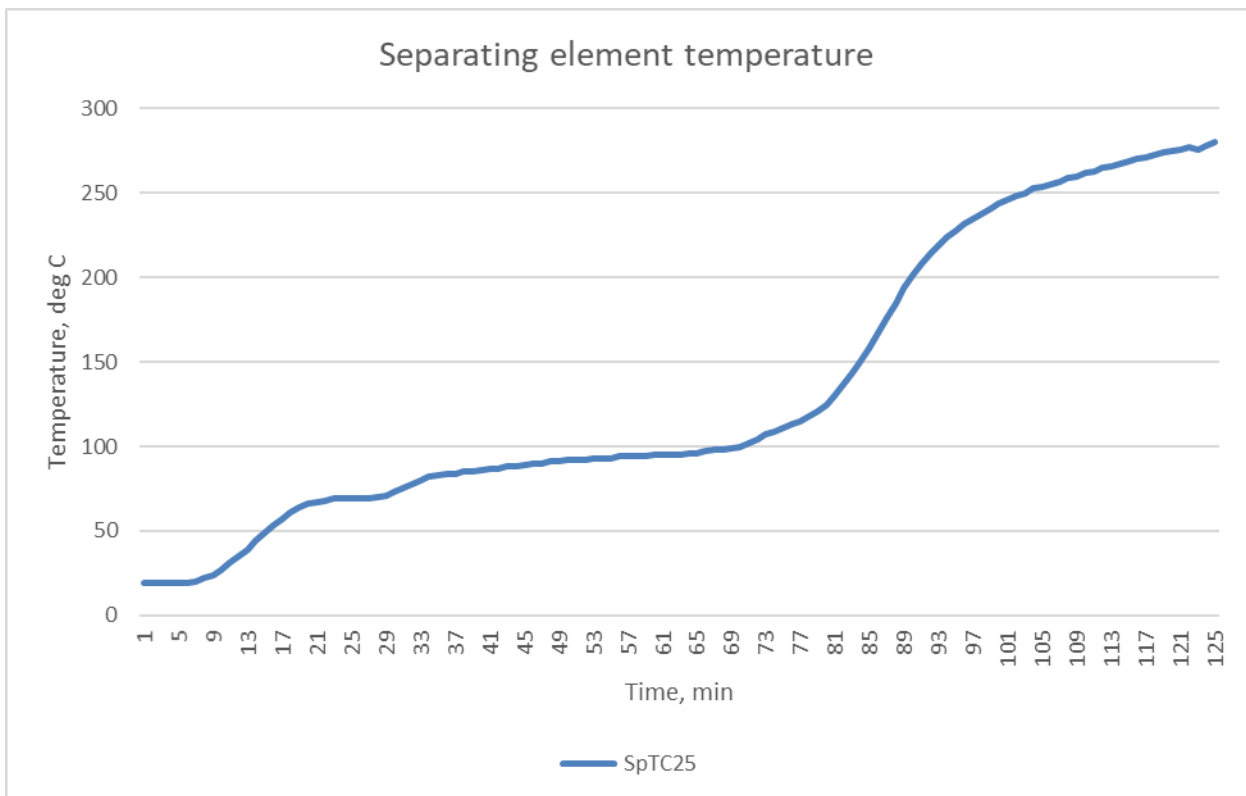
9. Separating element and main fire-stopping system

The separating element was constructed within the refractory frame, with a 140mm concrete lintel attached, reducing the frame size to 1200mm x 1060mm. Steel Track (1.3) was fixed to the bottom of the frame, and a Deflection Head (1.4) was fixed to the concrete lintel at 600mm centres. Four Studs (1.2) were fixed to the frame at 50mm, 200mm, 830mm and 1150mm from the unexposed left side of the refractory frame. The frame components were fixed together using screws (4.1). Two sections of plasterboard were cut to 1020mm x 1200mm, resulting in a 40mm gap between the lintel and the top edge of the plasterboard, to become the deflection seal. One layer of plasterboard (1.5) was fixed to each face of the frame, fixed using screws (4.2) at 300mm centres.

The Separating Element was constructed by the laboratory, in accordance with the client-supplied diagrams. The laboratory supplied the cable tray, D1 and D2 cables. The laboratory constructed the cable tray in accordance with the client's description. The laboratory was not involved in the service penetration preparation or installation.

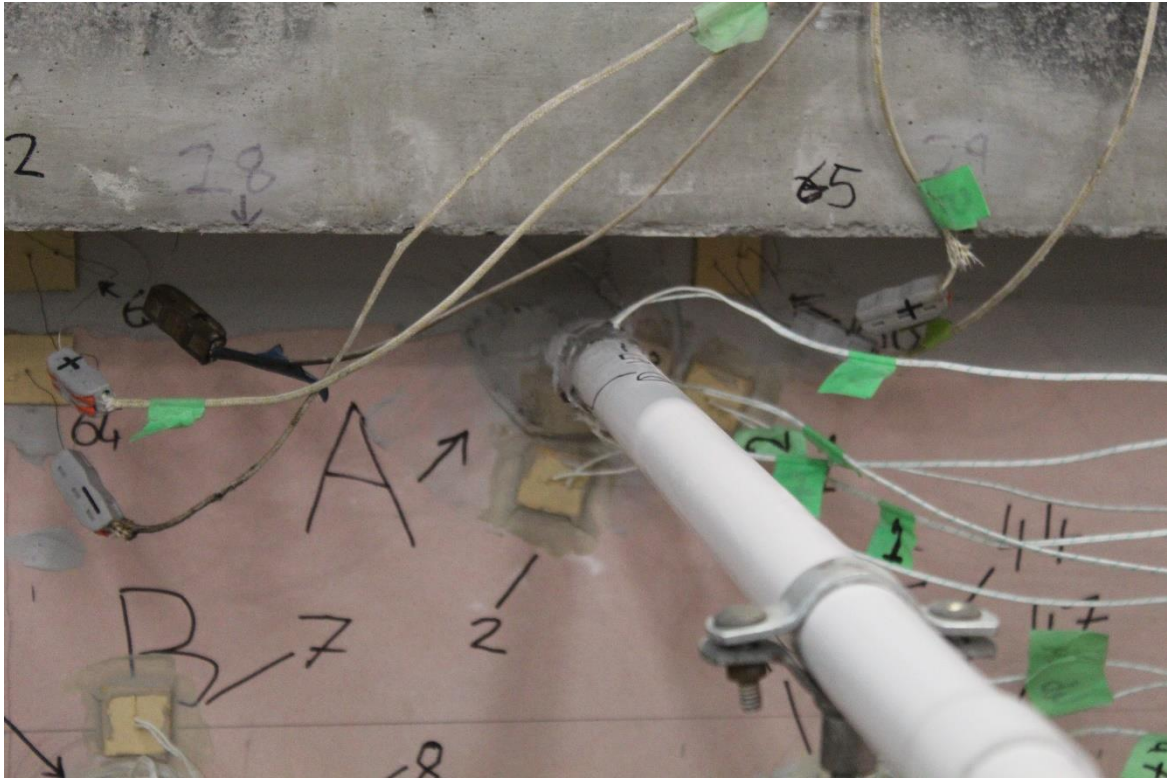
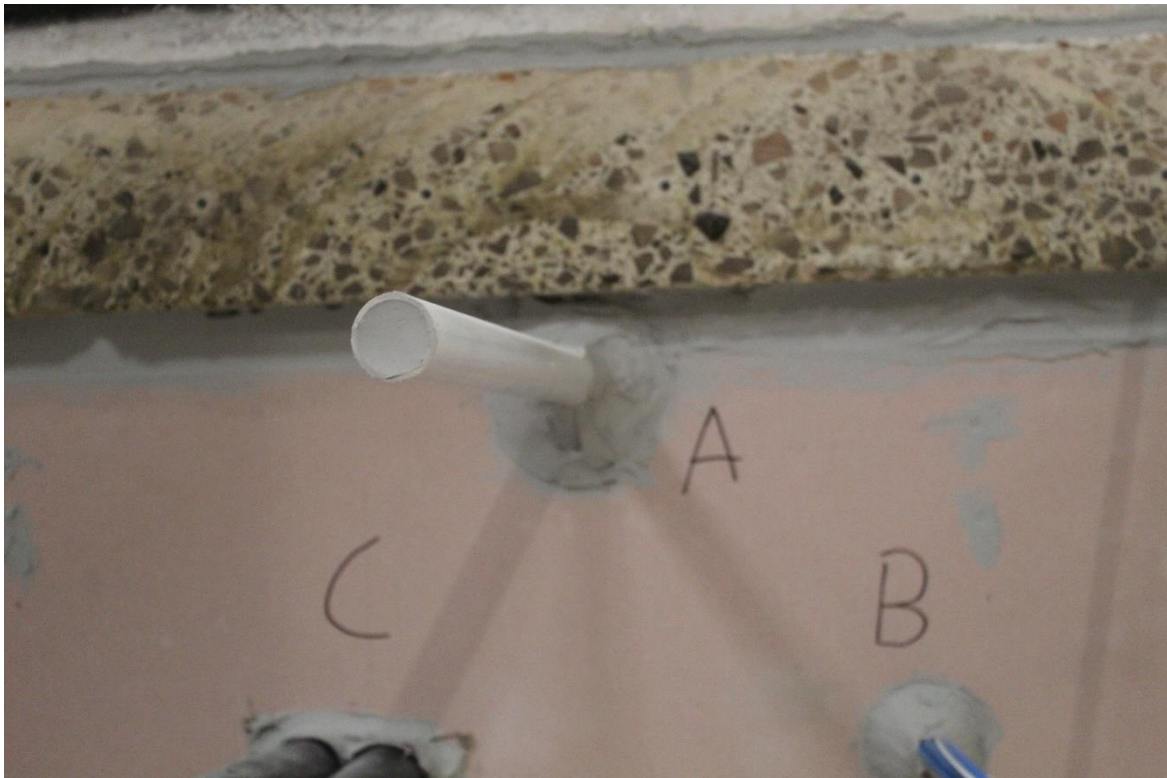
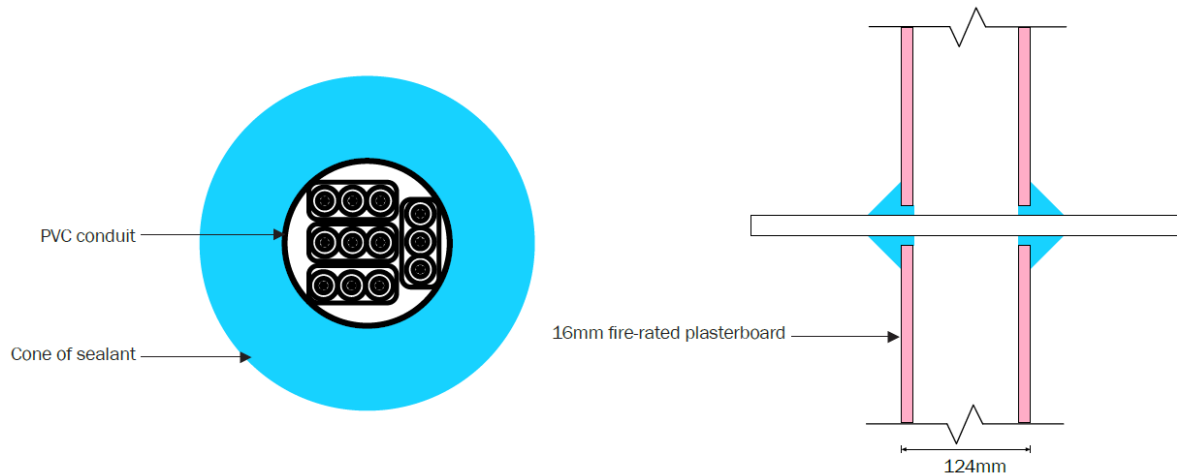
10.1 Specimen A

Penetration System		
A	Service	32DN PVC-U Pipe with Cables
	Service Details	Pipe (2.9), 3 x Cable (2.1), 3 x Cable (2.2), 3 x Cable (2.3), Sealant (3.1)
	Service Support	Unistrut structure at 500mm and 1500mm
	Aperture Size	45mm x 80mm
	Annular Spacing	Min: 1mm, Max: 48mm
Local Fire-stopping Protection		
Application	Symmetrical, capped from exposed face only	
Protection Used	<p>Aperture was cut into the separating element, 2mm below the concrete lintel. 3 x Cable (2.1), 3 x Cable (2.2), 3 x Cable (2.3) were bundled together and passed into the PVC-U pipe. PVC-U pipe (2.9) was passed through the aperture, extending 500mm from both faces.</p> <p>Polystyrene backing was installed in the aperture, recessed 13mm (nominal) from both faces. Sealant (3.1) was applied to the apertures, flush with the plasterboard. Once cured, a 25mm (nominal) sealant cone was applied to both faces.</p> <p>An additional section of PVC-U pipe was glued to the unexposed side, extending the total length of the pipe to 2000mm.</p>

Structural adequacy	Not applicable
Integrity	No failure at 124 min
Insulation	95 min

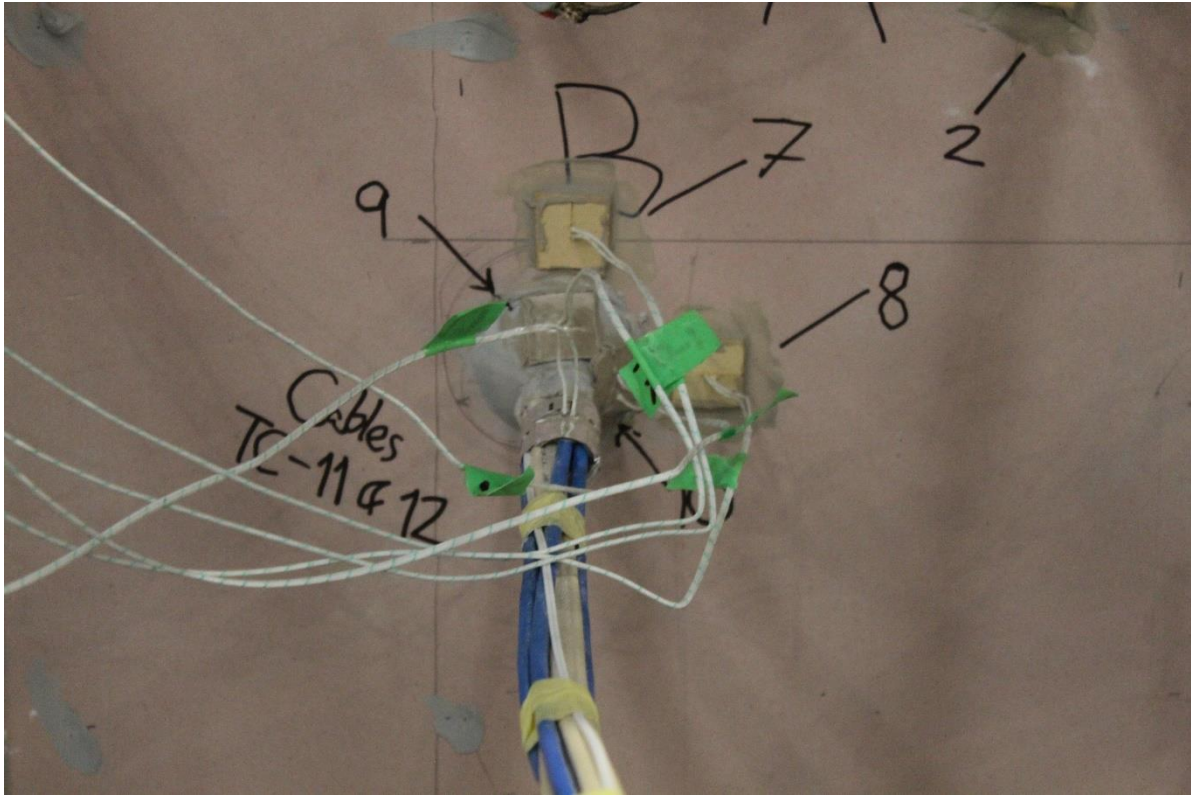
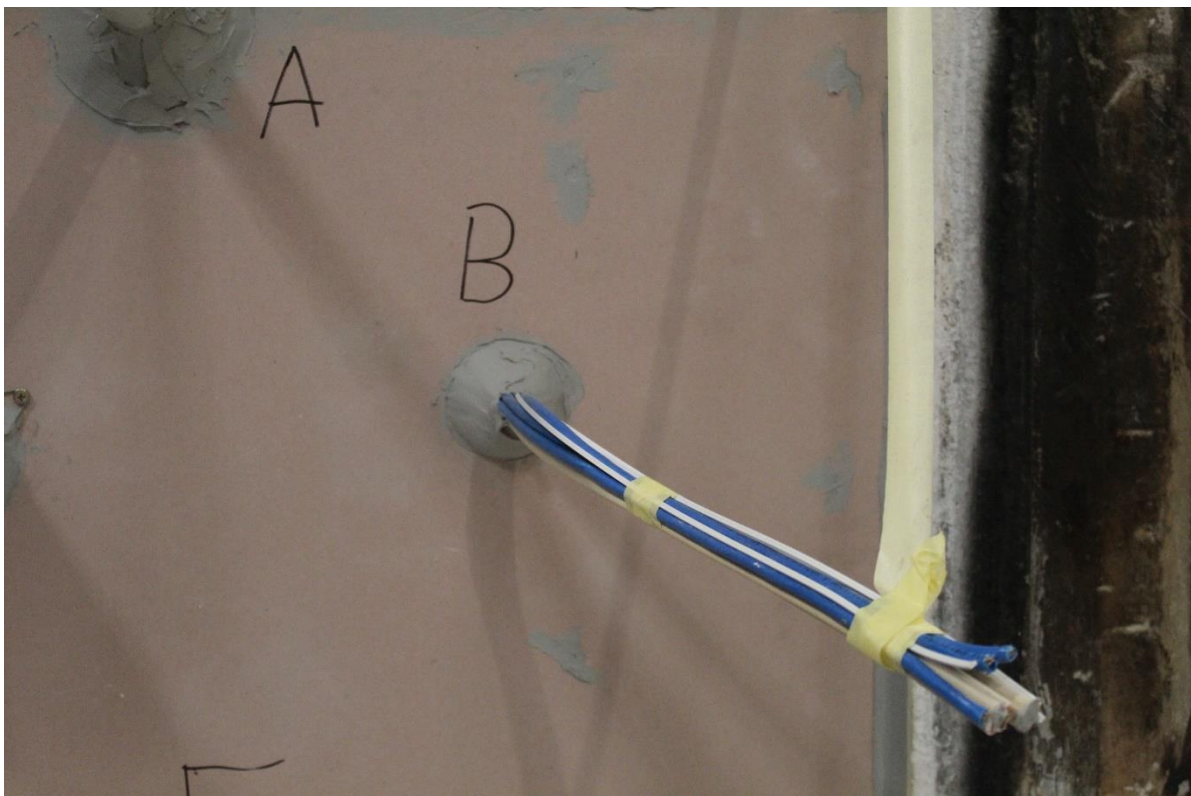
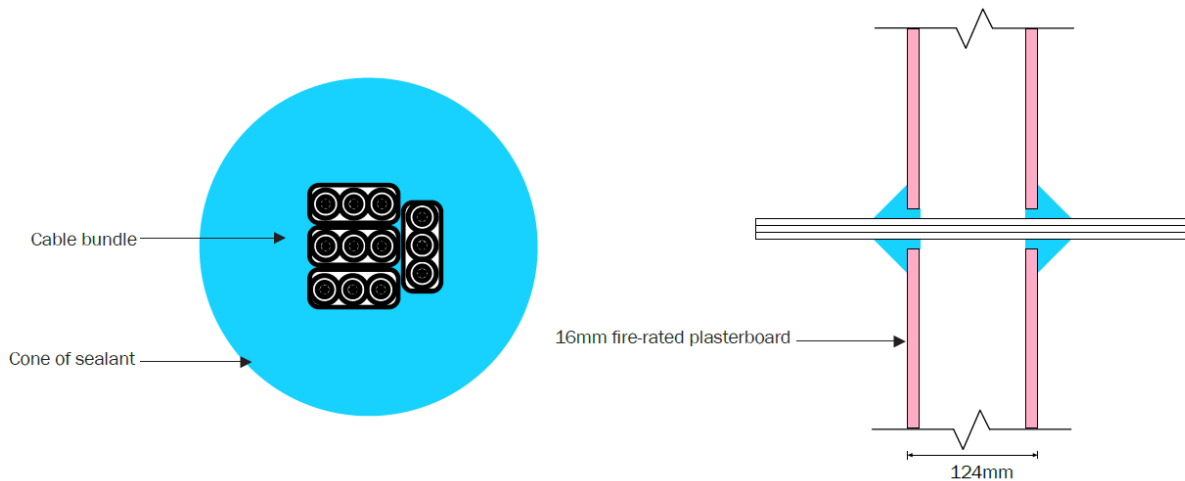
10.2 Specimen B

Penetration System		
B	Service	35mm Cable Bundle
	Service Details	3 x Cable (2.1), 3 x Cable (2.2), 3 x Cable (2.3), Sealant (3.1)
	Service Support	Unistrut structure at 500mm
	Aperture Size	50.70mm
	Annular Spacing	Min: 10mm, Max: 13mm
Local Fire-stopping Protection		
Application	Symmetrical, capped from exposed face only	
Protection Used	<p>Aperture was cut into the separating element. 3 x Cable (2.1), 3 x Cable (2.2), 3 x Cable (2.3) were bundled together and passed through the aperture, extending 500mm from both faces.</p> <p>Polystyrene backing was installed in the aperture, recessed 13mm (nominal) from both faces. Sealant (3.1) was applied to the apertures, flush with the plasterboard. Once cured, a 25mm (nominal) sealant cone was applied to both faces.</p>

Structural adequacy	Not applicable
Integrity	No failure at 124 min
Insulation	91 min

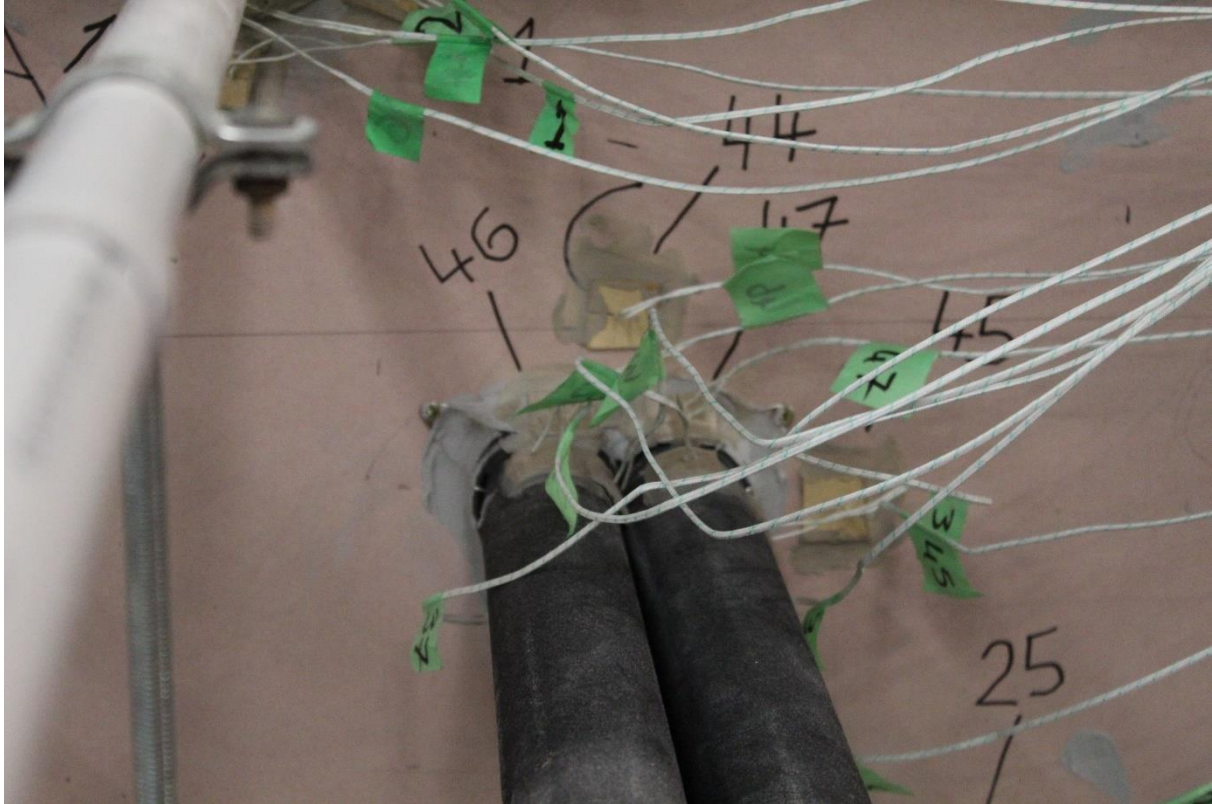
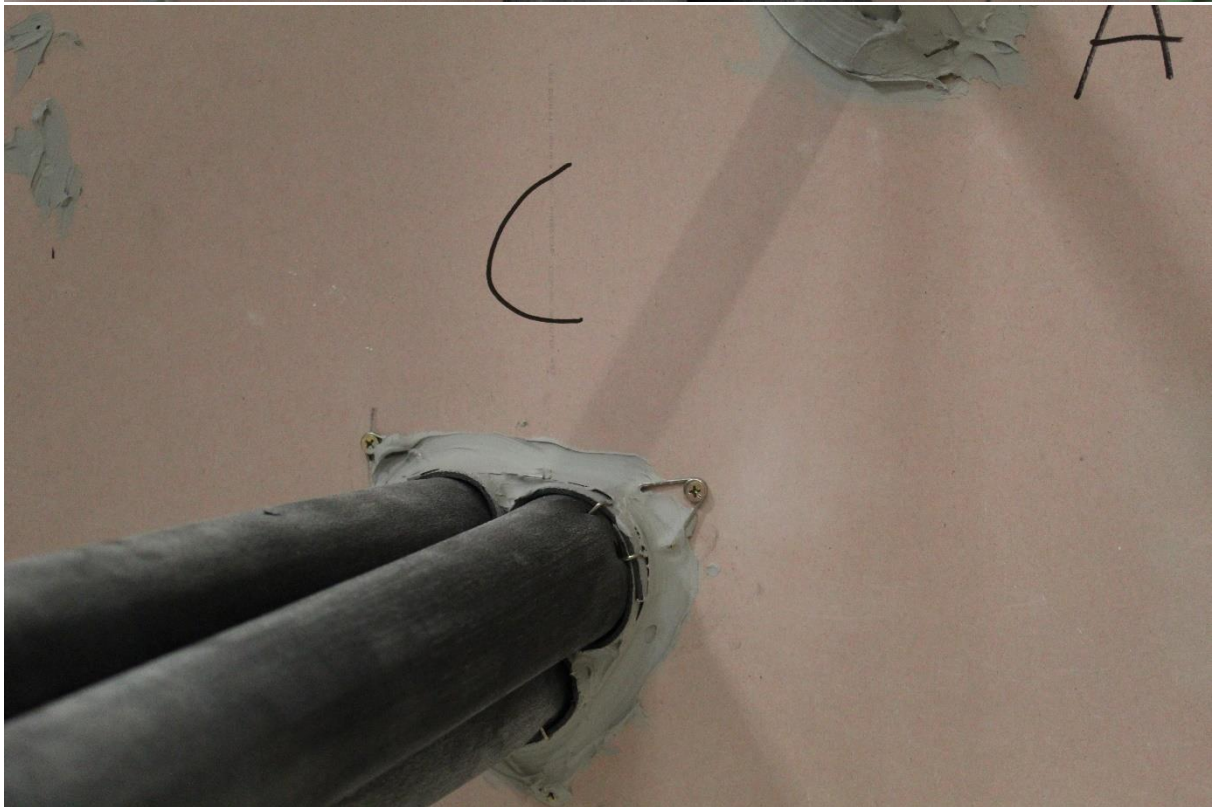
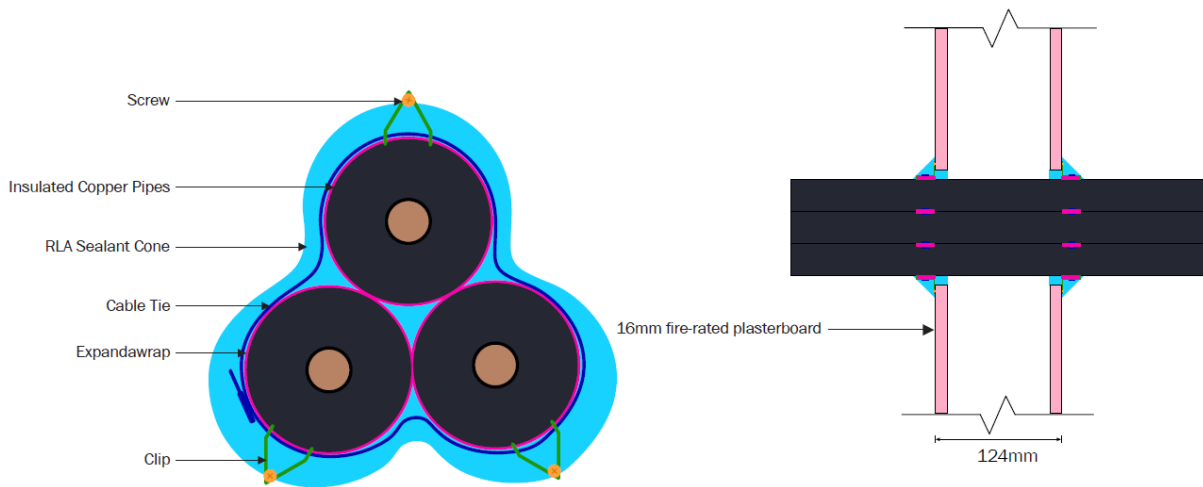
10.3 Specimen C

Penetration System		
C	Service	3 x 20DN Copper pipes with Armaflex insulation
	Service Details	3 x Armaflex (2.5), 3 x Copper Pipe (2.4), Intumescent Strap (5.2), Steel Wire clips, (4.4), Screws, (4.2), Cable Ties (4.3)
	Service Support	Unistrut structure at 500mm
	Aperture Size	3 x 57.70mm
	Annular Spacing	Min: 0mm, Max: 1mm
	Local Fire-stopping Protection	
	Application	Symmetrical, capped from exposed face only
	Protection Used	<p>3 holes were cut in the separating element such that the aperture can accommodate 3 pipes. The overall dimensions of the aperture were 115mm x 110mm. A pipe (2.4) was placed into the Armaflex and passed through the aperture extending 500mm from both faces. This was repeated for all 3 pipes.</p> <p>A length of Intumescent strap (5.2) was cut to wrap around each pipe one time, with approximately 20mm overlap. The strap was fixed to the separating element using steel wire clips (4.4) and screws (4.2). This was repeated for all 3 pipes. A 25mm (nominal) radius bead of sealant was applied between the intumescent strip and the separating element.</p>

Structural adequacy	Not applicable
Integrity	No failure at 124 min
Insulation	71 min

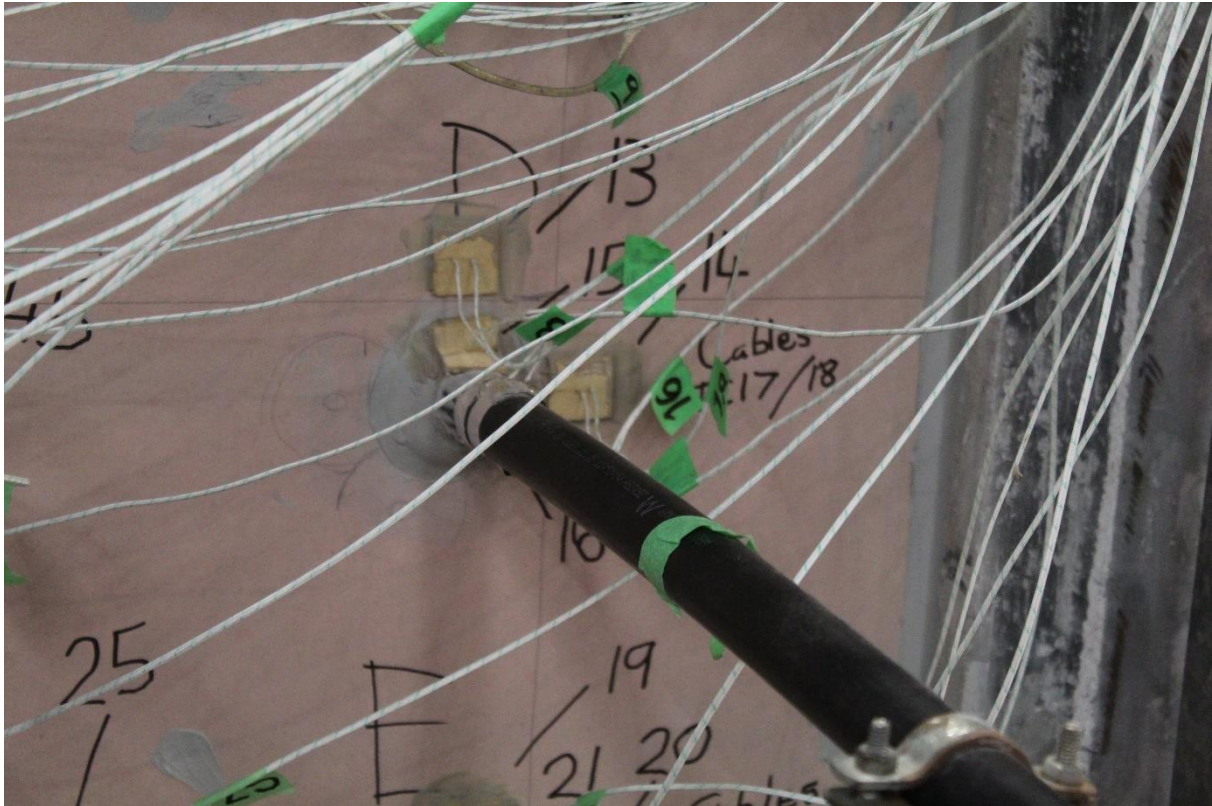
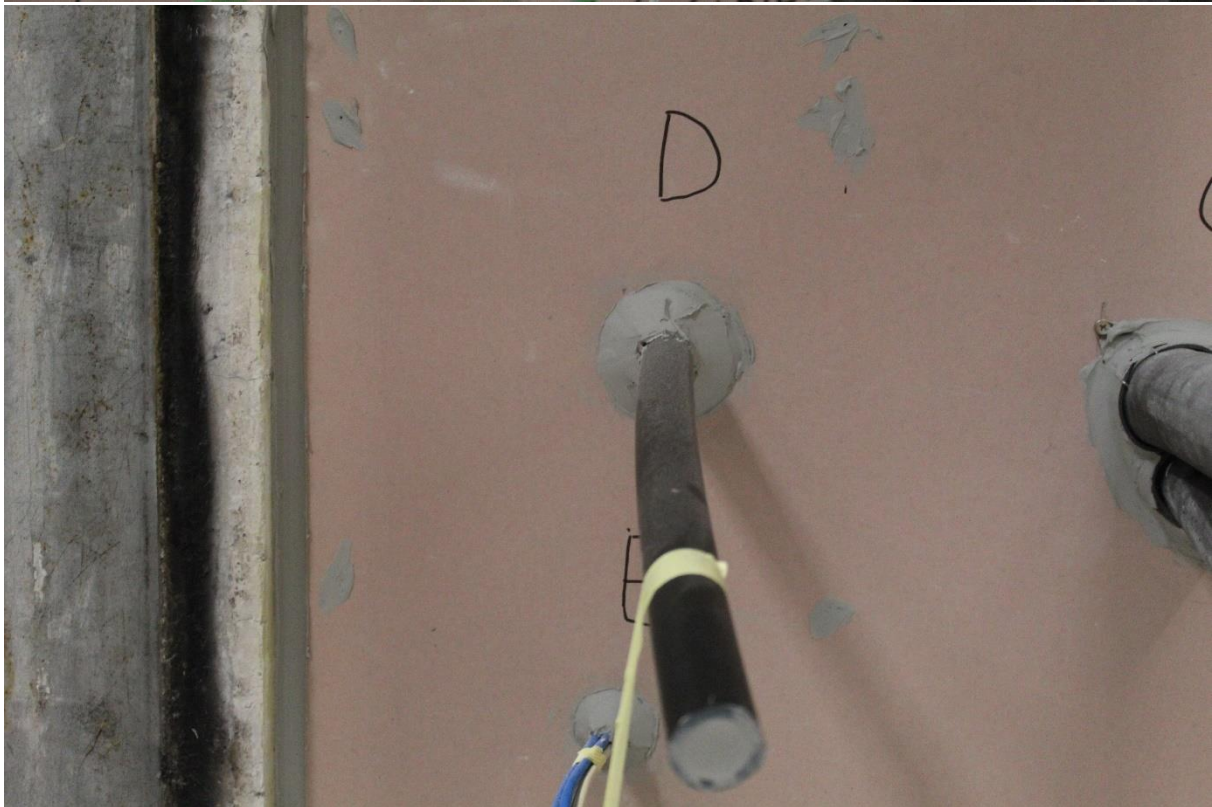
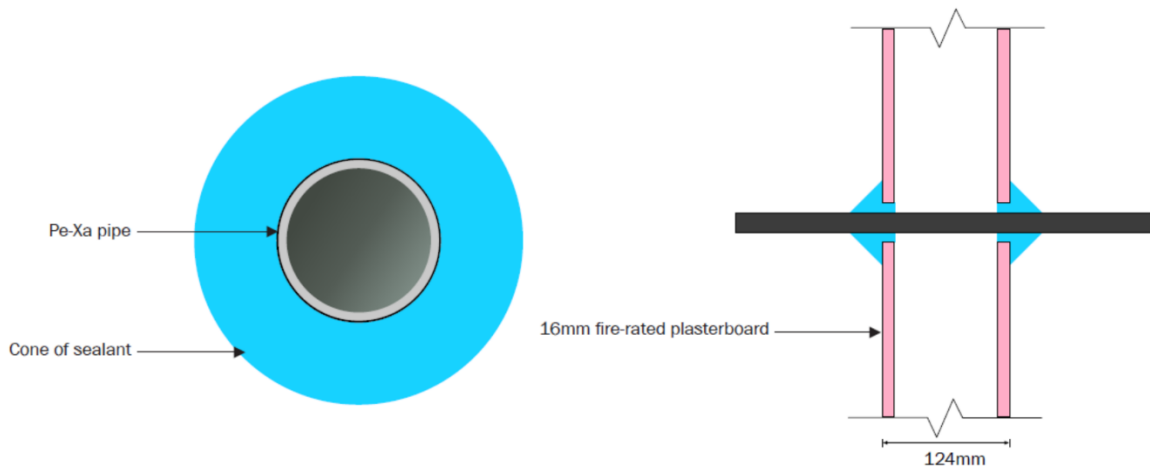
10.4 Specimen D

Penetration System		
D	Service	32DN Pe-Xa Pipe
	Service Details	Pipe (2.6), Sealant (3.1)
	Service Support	Unistrut structure at 500mm and 1500mm
	Aperture Size	50.79mm
	Annular Spacing	Min: 8mm, Max: 11mm
Local Fire-stopping Protection		
Application	Symmetrical, capped from exposed face only	
Protection Used	Aperture was cut into the separating element, then Pe-Xa pipe (2.6) was passed through the aperture, extending 500mm from the exposed face, and 2000mm from the unexposed face. Polystyrene backing was installed in the aperture, recessed 13mm (nominal) from both faces. Sealant (3.1) was applied to the apertures, flush with the plasterboard. Once cured, a 25mm (nominal) sealant cone was applied to both faces.

Structural adequacy	Not applicable
Integrity	29 min
Insulation	15 min

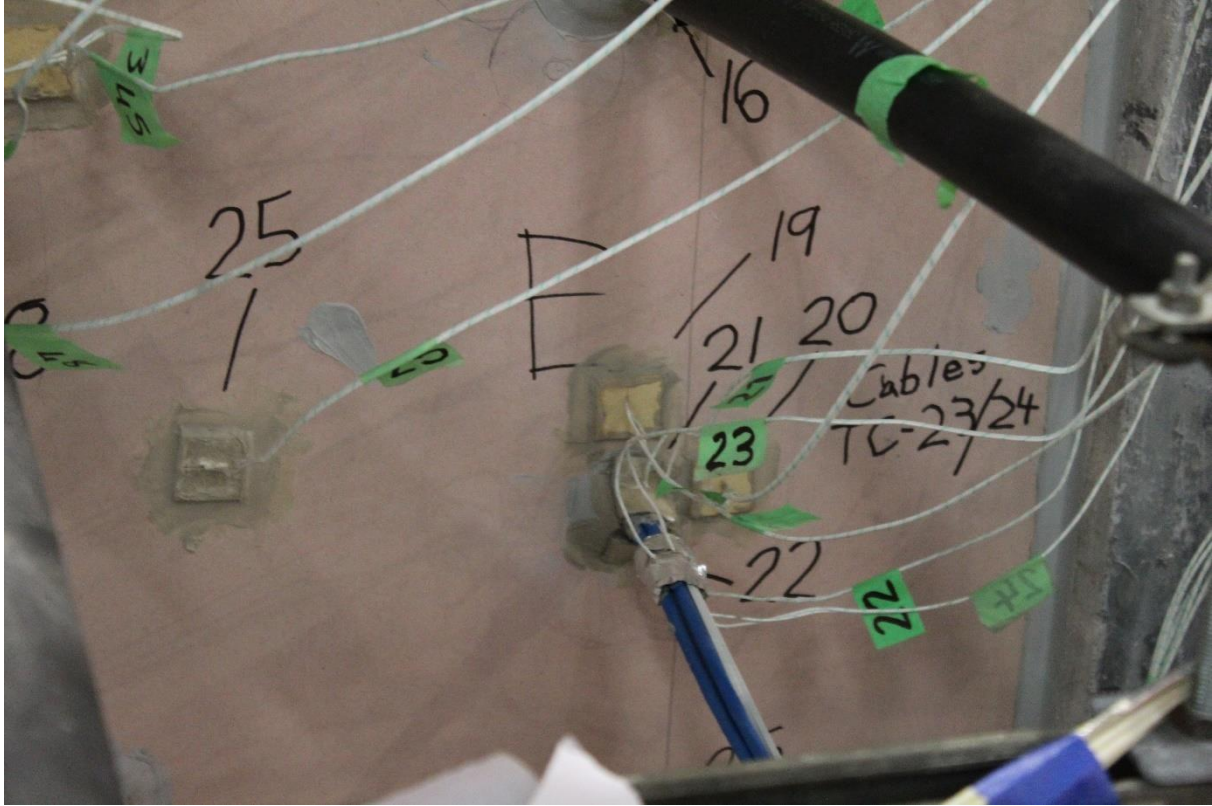
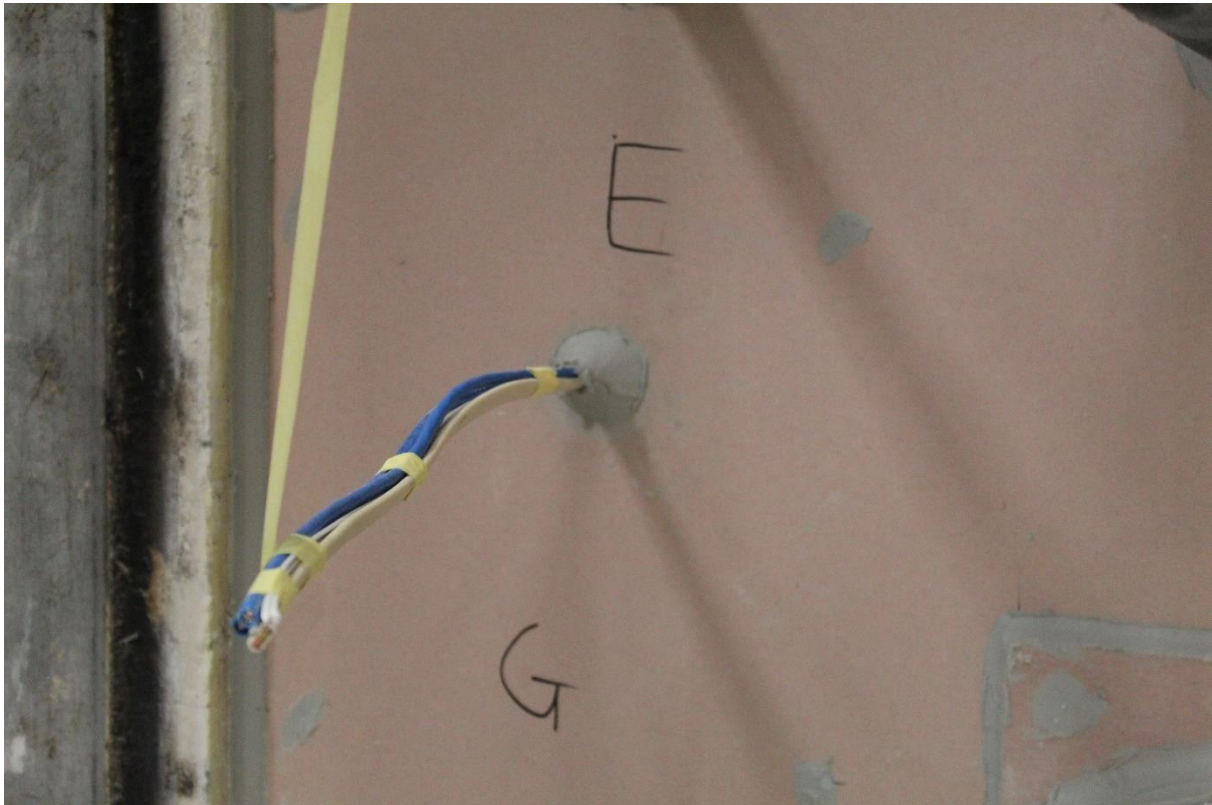
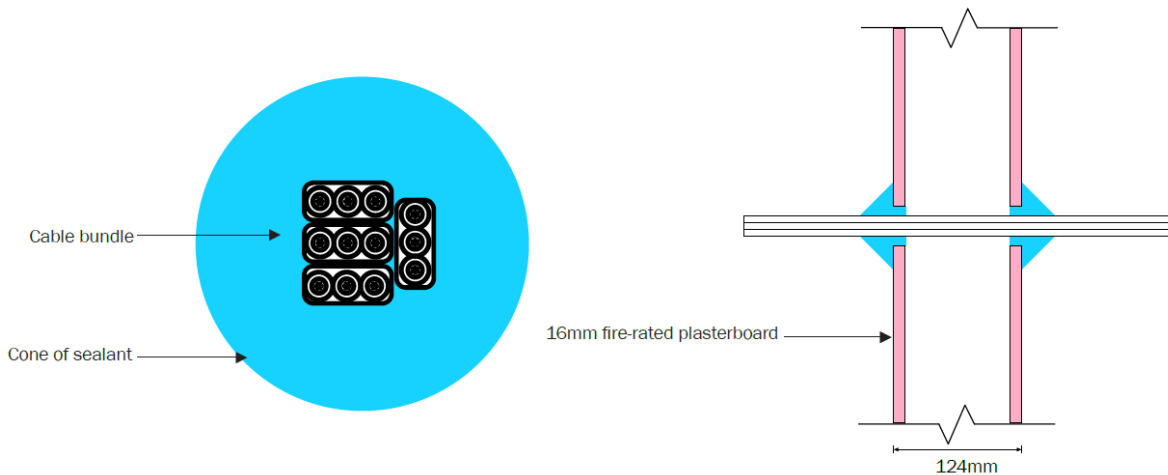
10.5 Specimen E

Penetration System		
E	Service	15mm Cable Bundle
	Service Details	1 x Cable (2.1), 2 x Cable (2.2), 3 x Cable (2.3), Sealant (3.1)
	Service Support	Unistrut structure at 500mm
	Aperture Size	32.84mm
	Annular Spacing	Min: 10mm, Max: 13mm
	Local Fire-stopping Protection	
Application	Symmetrical, capped from exposed face only	
Protection Used	Aperture was cut into the separating element. 1 x Cable (2.1), 2 x Cable (2.2), 3 x Cable (2.3) were bundled together and passed through the aperture, extending 500mm from both faces. Polystyrene backing was installed in the aperture, recessed 13mm (nominal) from both faces. Sealant (3.1) was applied to the apertures, flush with the plasterboard. Once cured, a 25mm (nominal) sealant cone was applied to both faces.

Structural adequacy	Not applicable
Integrity	No failure at 124 min
Insulation	82 min

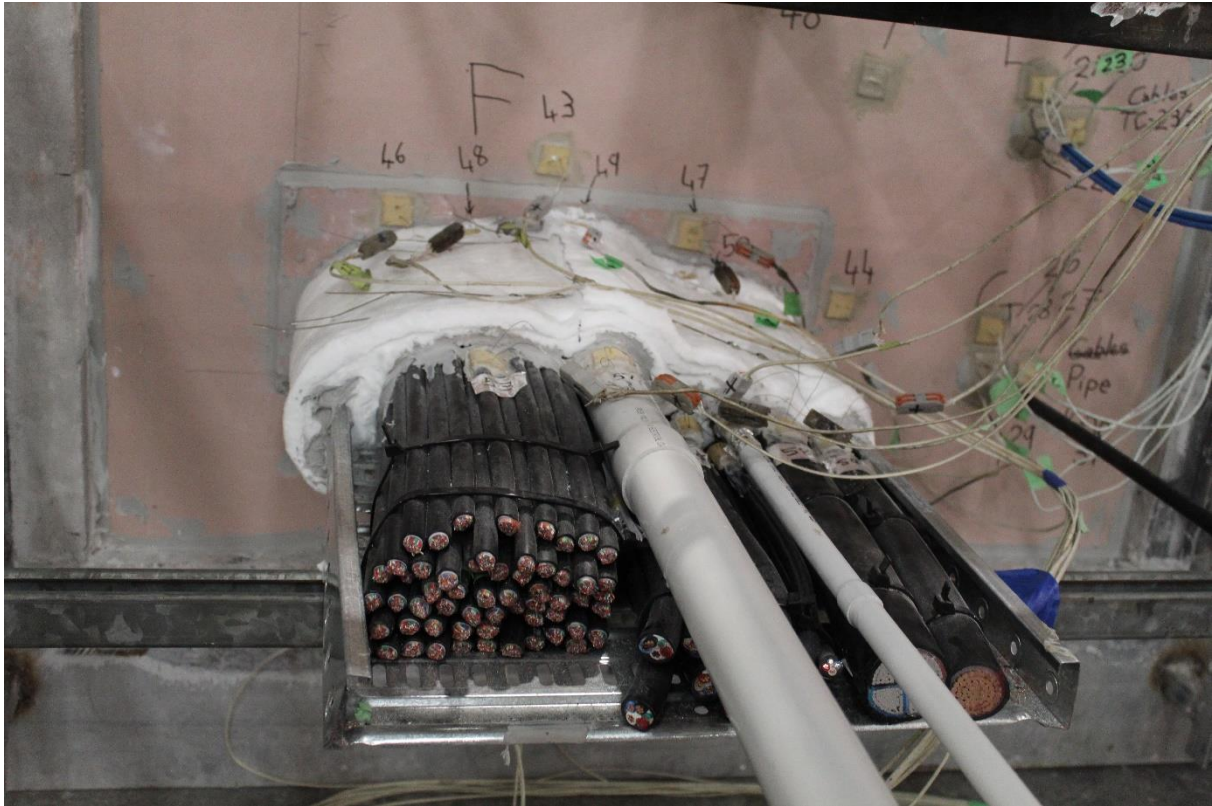
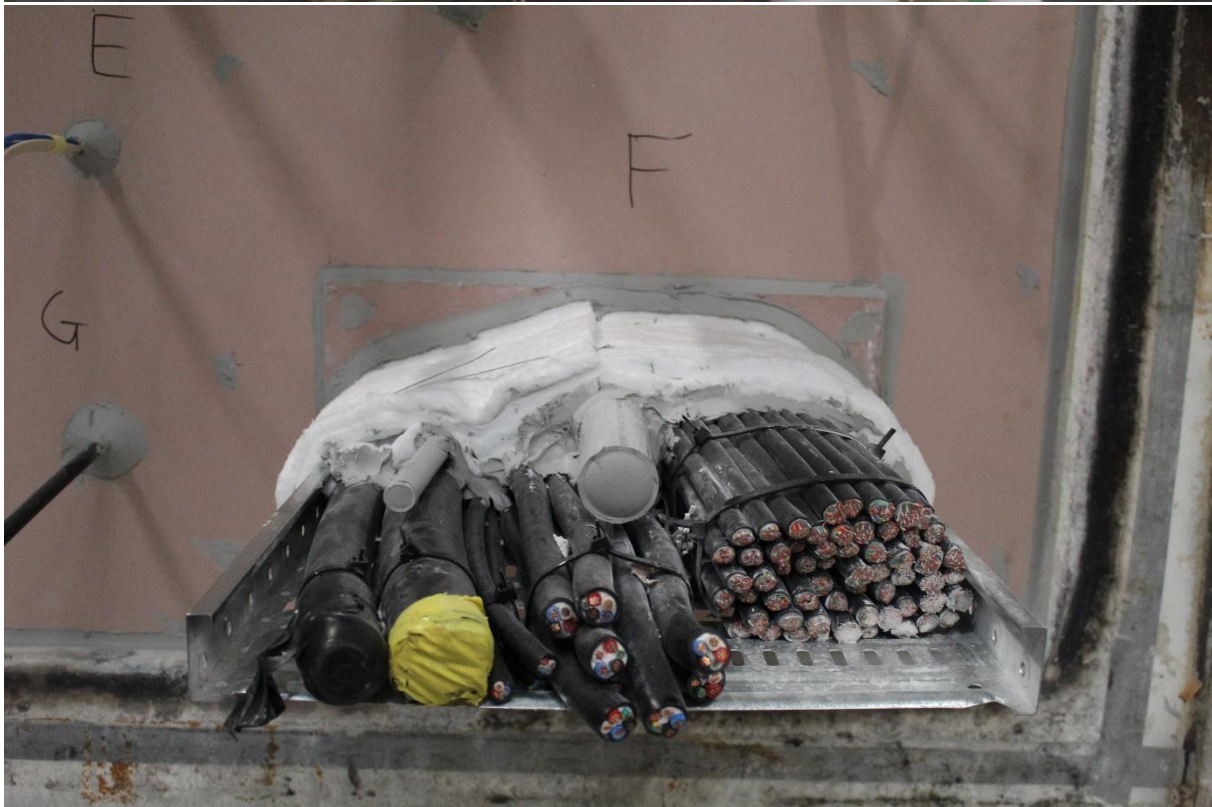
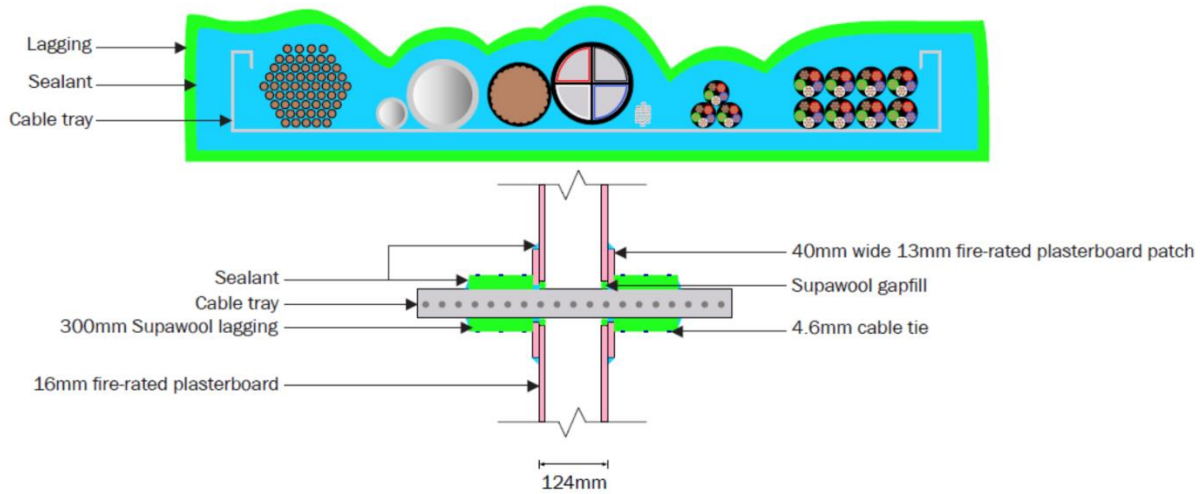
10.6 Specimen F

Penetration System			
F	Service	D1 + D2 + assorted cable bundle + Pipe on Cable Tray	
	Service Details	Cable Tray (2.11), Pipe (2.8), Pipe (2.10), 11 x Cable (2.1), 32 x Cable (2.2), 13 x Cable (2.3), 1 x Cable (2.12), 1 x Cable (2.13), 3 x Cable (2.14), 8 x Cable (2.15), 60 x Cable (2.16), Ceramic Fibre Blanket (5.1), Cable ties (4.3) Sealant (3.1). Cable configurations and additional services were put together upon the request of Client.	
	Service Support	Unistrut structure at 500mm	
	Aperture Size	460mm x 110mm	
	Annular Spacing	Min: 1mm, Max: 60mm	
	Local Fire-stopping Protection		
	Application	Symmetrical, capped from exposed face only	
Protection Used	<p>Aperture cut into the separating element. The 60 x D2 Cables (2.16) were bundled using cable ties and placed on the unexposed left side of the cable tray (2.11). The D1 Cable configuration was placed next to the D2 configuration in the order of 8 x Cable (2.15), 3 x Cable (2.14), 1 x Cable (2.13), then 1 x Cable (2.12). The cables were secured to the cable tray with cable ties. The Cable tray was placed through the aperture.</p> <p>10 x Cable (2.1), 10 x Cable (2.2), and 10 x Cable (2.3) were bundled together and placed in the pipe (2.10).</p> <p>1 x Cable (2.1), 2 x Cable (2.2), and 3 x Cable (2.3) were bundled together and placed in the pipe (2.8). 20 x Cable (2.2) were bundled together.</p>

<p>Sections of the separating element were cut to accommodate the additional pipes and cable bundle. The bundle was placed between the D1 and D2 configurations on the cable tray. The pipe (2.8) was placed on top of the D1 configuration between the 8 x Cable (2.15) and the 3 x Cable (2.14). The pipe (2.10) was placed between the D1 and D2 configurations on top of the additional cable bundle. The additional pipes and cable bundle extended 500mm from both faces.</p> <p>Sections of ceramic fibre blanket (5.1) were cut and pushed into the aperture gaps around the perimeter of the cable bundle. An additional section of plasterboard was cut to follow the profile of the cable tray and was fixed to the separating element with screws. This resulted in a maximum aperture gap of approximately 20mm, and a minimum aperture gap of 2mm. A bead of sealant was applied to the perimeter junction between the additional plasterboard and separating element plasterboard, and the ceramic fibre recess within the aperture was filled with sealant, resulting in a thickness of 30mm (nominal). Sealant was applied flush with the additional plasterboard layer. Once cured, a 25mm (nominal) radius bead of sealant was applied between the plasterboard and the cable tray around the perimeter.</p> <p>The outside of the cable tray was wrapped with two and a half revolutions of ceramic fibre blanket. The end of the blanket measured 300mm from the separating element. The ceramic blanket was secured to the cable tray using cable trays (4.3). The remaining gaps between the cable tray and ceramic blanket were filled using more ceramic blanket.</p> <p>A 25mm (nominal) radius bead of sealant was applied between the plasterboard and the ceramic blanket around the perimeter. The PVC pipes were extended to 2000mm from the unexposed face by gluing another length to the existing pipes.</p>

Structural adequacy	Not applicable
Integrity	No failure at 124 min
Insulation	96 min
