Test report # PF21009-A

Fire resistance tests for wall penetrations

Test method: AS 1530.4:2014

Report Date 17/09/2021

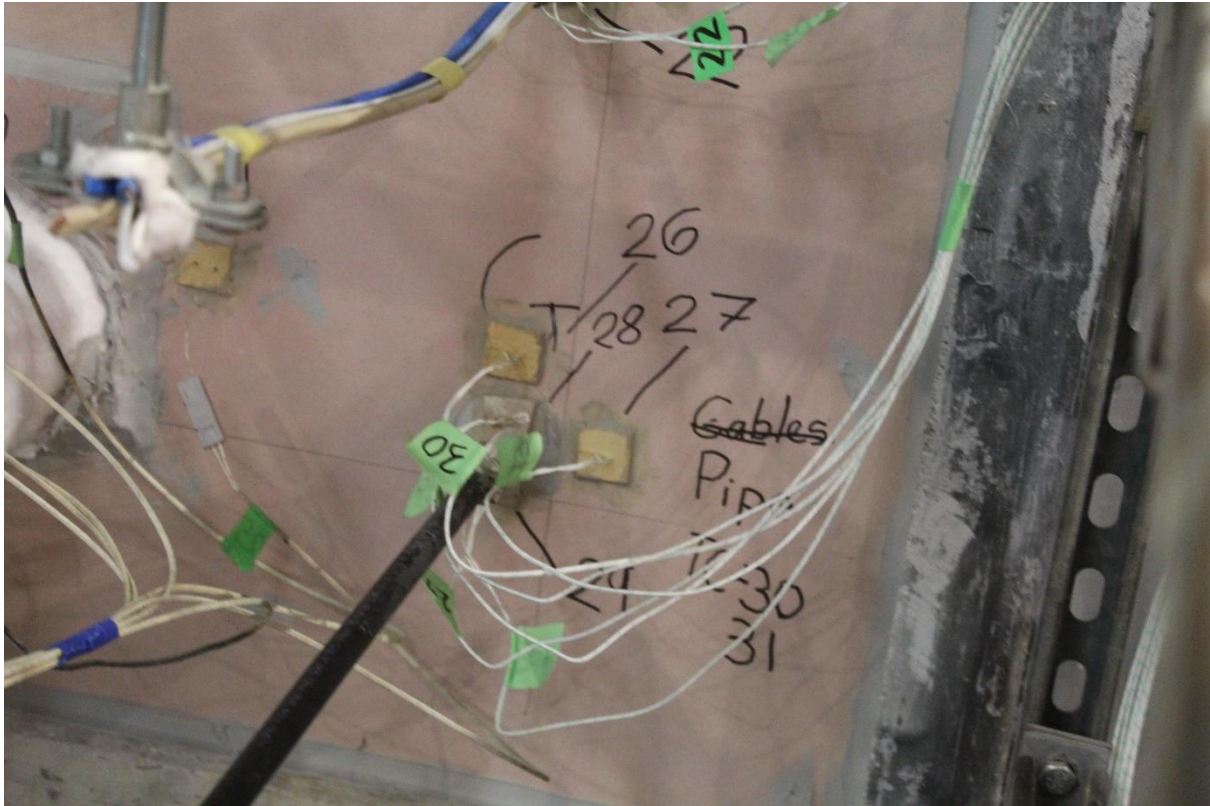
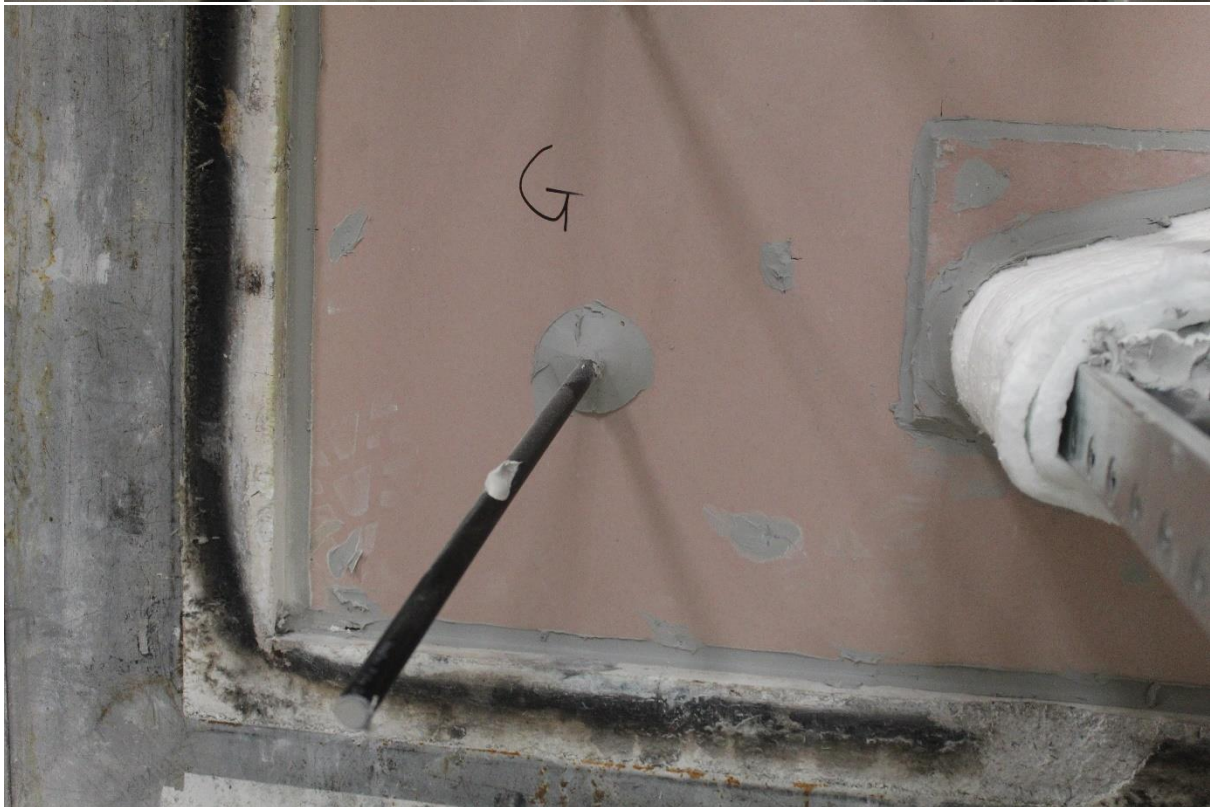
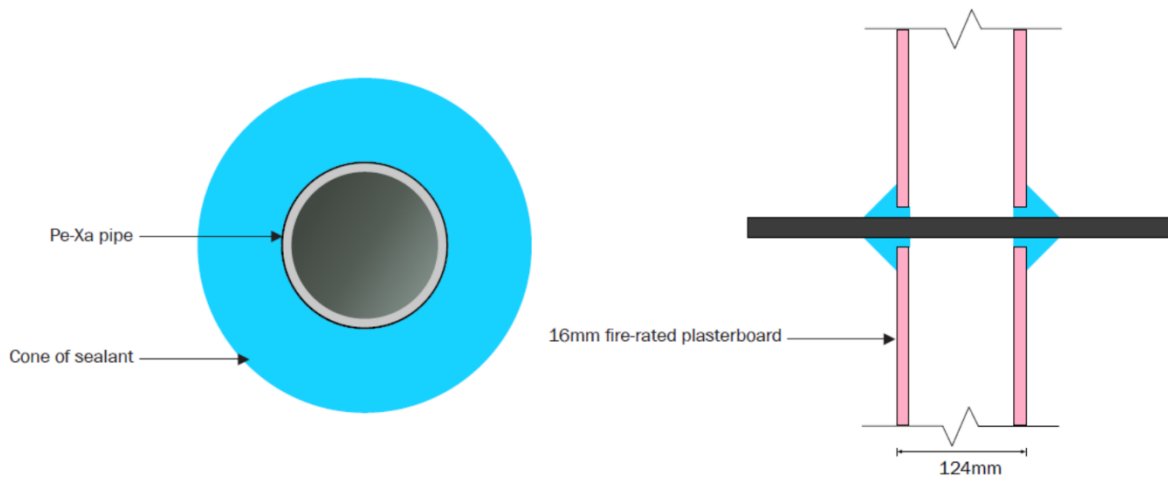
10.7 Specimen G

Penetration System		
G	Service	16DN Pe-Xa Pipe
	Service Details	Pipe (2.7), Sealant (3.1)
	Service Support	Unistrut structure at 500mm and 1500mm
	Aperture Size	32.90mm
	Annular Spacing	Min: 8mm, Max: 9mm
Local Fire-stopping Protection		
Application	Symmetrical, capped from exposed face only	
Protection Used	Aperture was cut into the separating element, then Pe-Xa pipe (2.7) was passed through the aperture, extending 500mm from the exposed face, and 2000mm from the unexposed face Polystyrene backing was installed in the aperture, recessed 13mm (nominal) from both faces. Sealant (3.1) was applied to the apertures, flush with the plasterboard. Once cured, a 25mm (nominal) sealant cone was applied to both faces.

Structural adequacy	Not applicable
Integrity	No failure at 125 min
Insulation	88 min

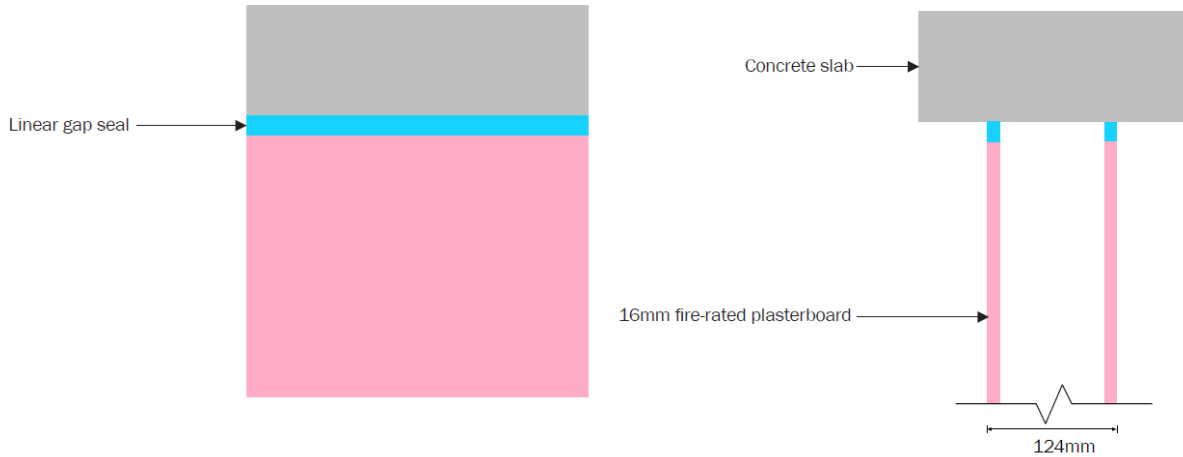
10.8 Specimen H

Penetration System		
H	Service	40mm Deflection Head Seal
	Service Details	Sealant (3.1)
	Service Support	N/A
	Aperture Size	1200mm x 40mm
	Annular Spacing	N/A
	Local Fire-stopping Protection	
Application	Symmetrical	
Protection Used	Backing was placed on top of the deflection head to reduce the recess from 16mm to 13mm. The remaining gaps from the deflection head service penetration were packed with backing, making it flush with the rest of the deflection head seal gap. Sealant was applied to the recess, flush with the plasterboard.

Structural adequacy	Not applicable
Integrity	No failure at 124 min
Insulation	80 min

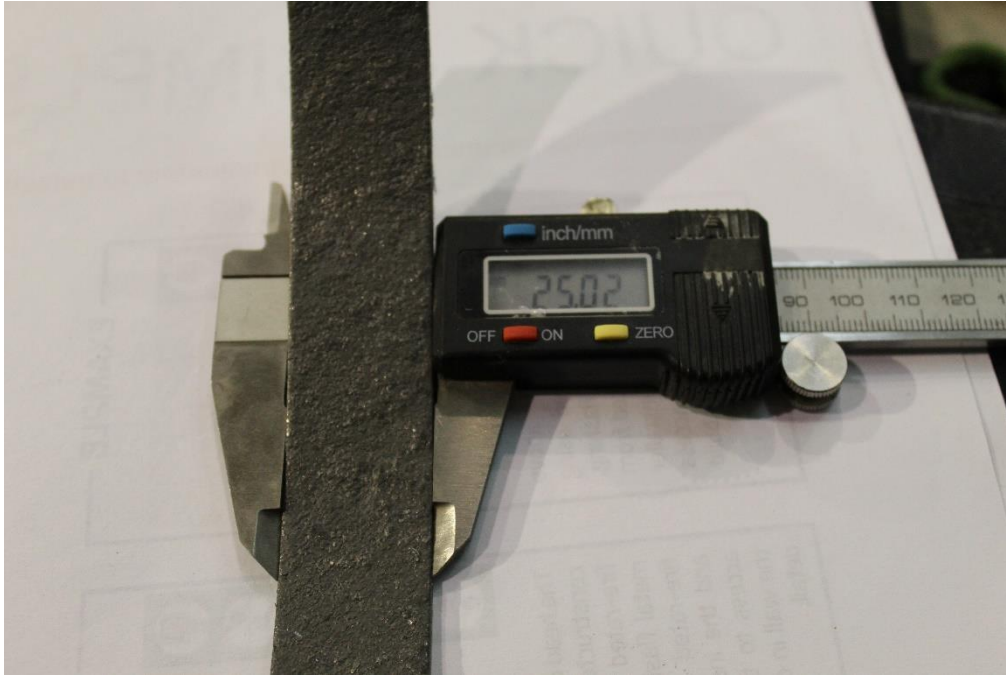
Item 5.2

Thickness (T): 13mm
		Density (ρ): 128kg/m ³
	Installation	Wrapped around services
5.2	Item / Product Name	Expandawrap - Intumescent Strip
	Measurements	Width (W): 25mm
		Thickness (T): 2.75mm
	Installation	Wrapped around services
