## **Test report # PF21008-A**

**Fire resistance tests for wall penetrations**

**Test method: AS 1530.4:2014**

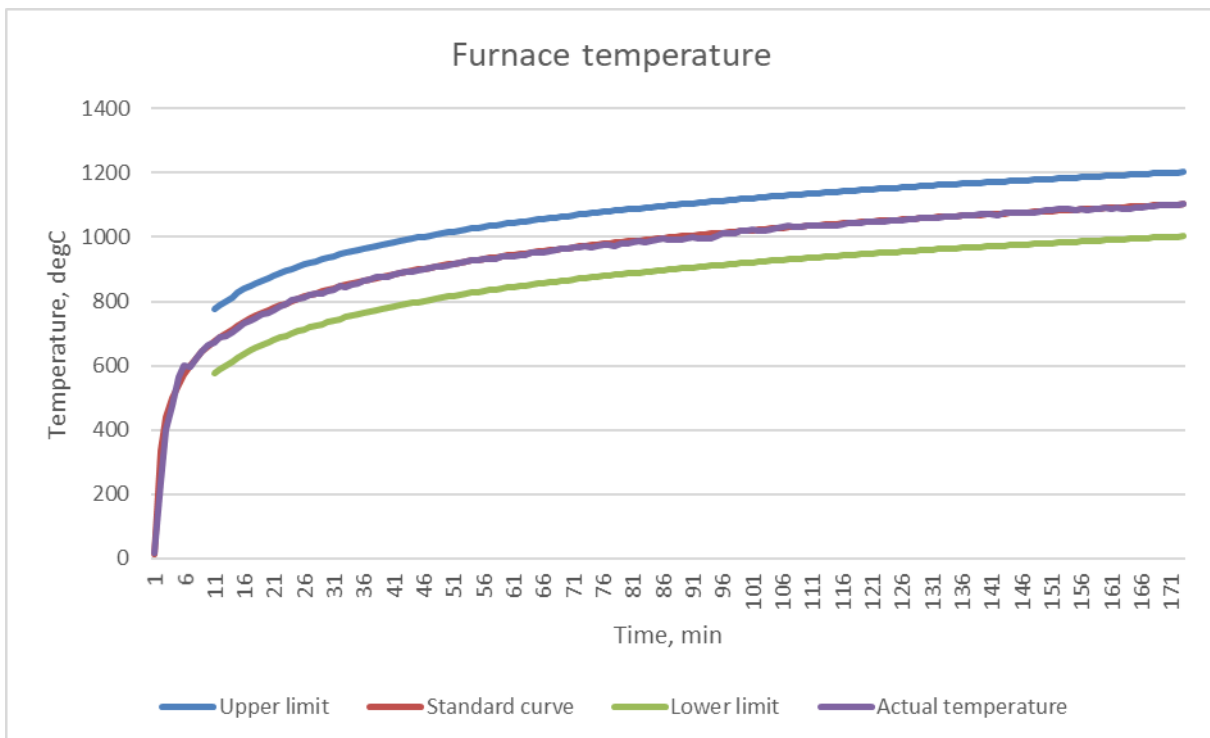
### 6.1 Furnace Temperature

The furnace was controlled to follow the temperature/time relationship specified in AS 1530.4-2014 as closely as possible.

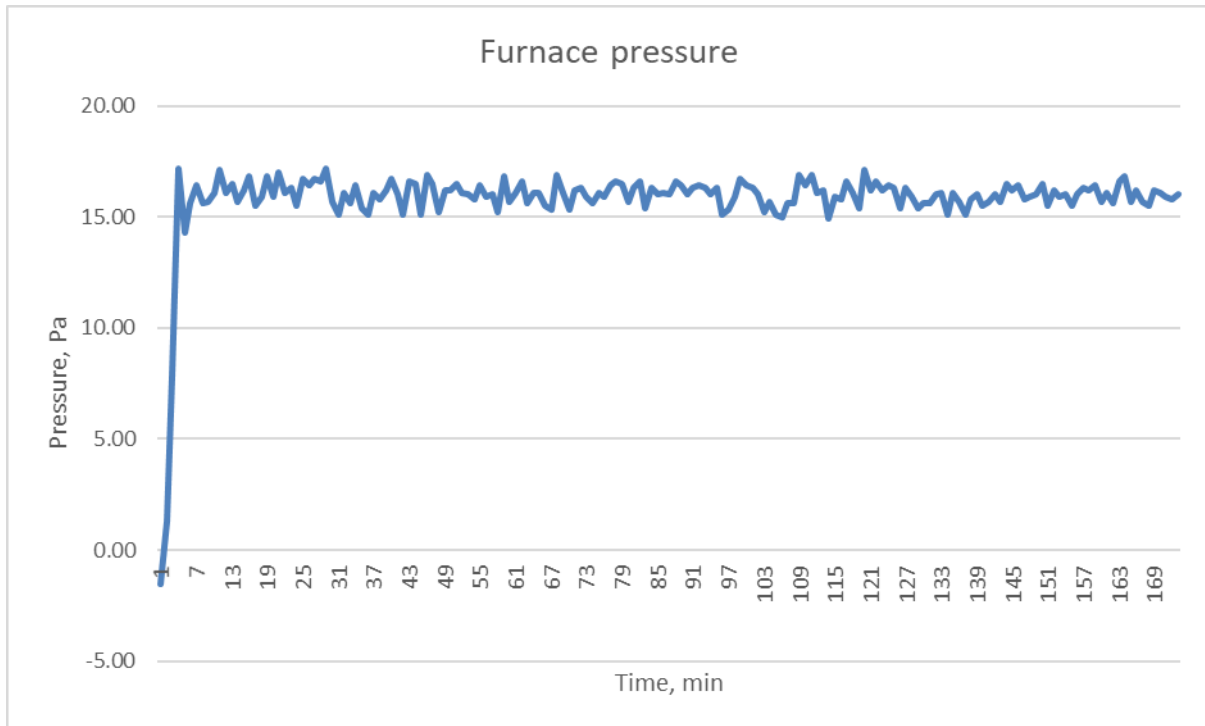
## 6.3 Pressure Readings

The furnace pressure was maintained at  $16 \pm 3$  Pa with respect to atmosphere. The probe was located 500mm above the furnace floor.

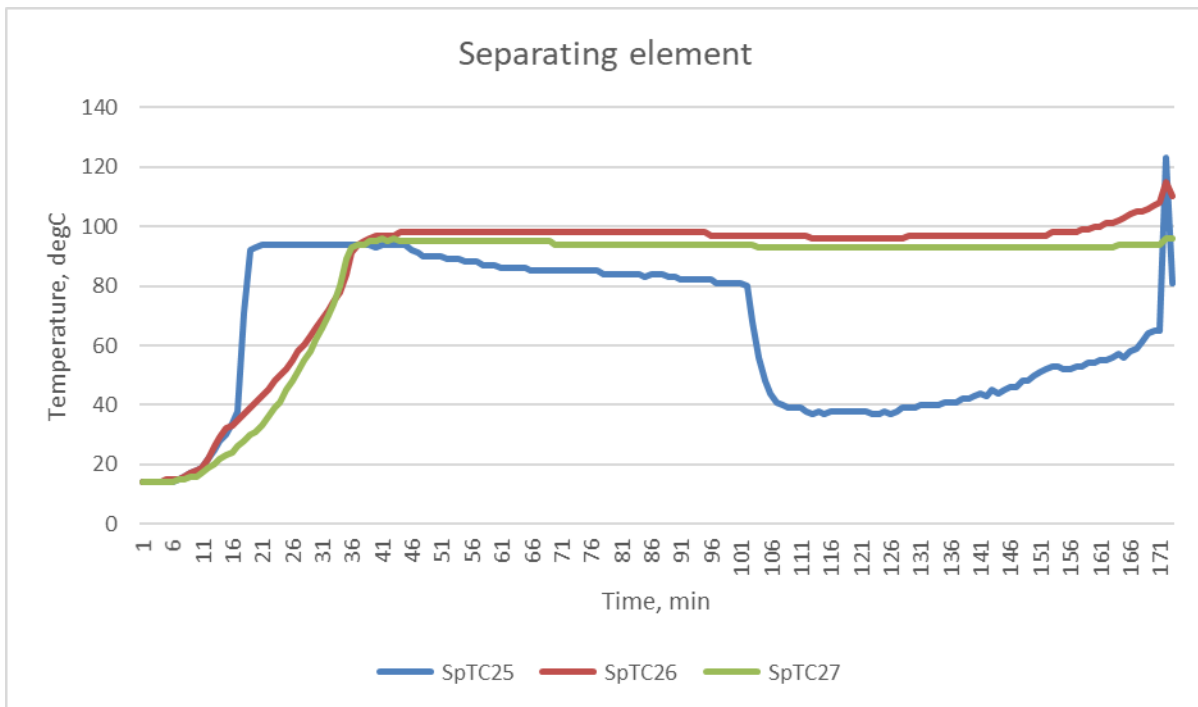
The separating element comprised of 5 Speedpanels (1.2), one of which had been cut near the tongue edge of the panel to fit within the frame. The bottom ends of the 5 panels were placed within a C-Track (1.3), then fixed using screws (4.1) at 500mm centres. The left and right sides of the Speedpanels were then fixed to a C-Track using the same method. The top edge of the Speedpanels was also cut to fit within the frame. The final length of C-Track was fixed to the top edge, then the wall was fixed within the refractory frame using slotted angles. The edges of the wall were packed with ceramic fibre, then remaining gaps were filled using sealant (3.1). Gaps between the C-Track and Speedpanel were also sealed using sealant in accordance with the application manual supplied by the client.

Apertures were cut after the completion of the separating element by the client.

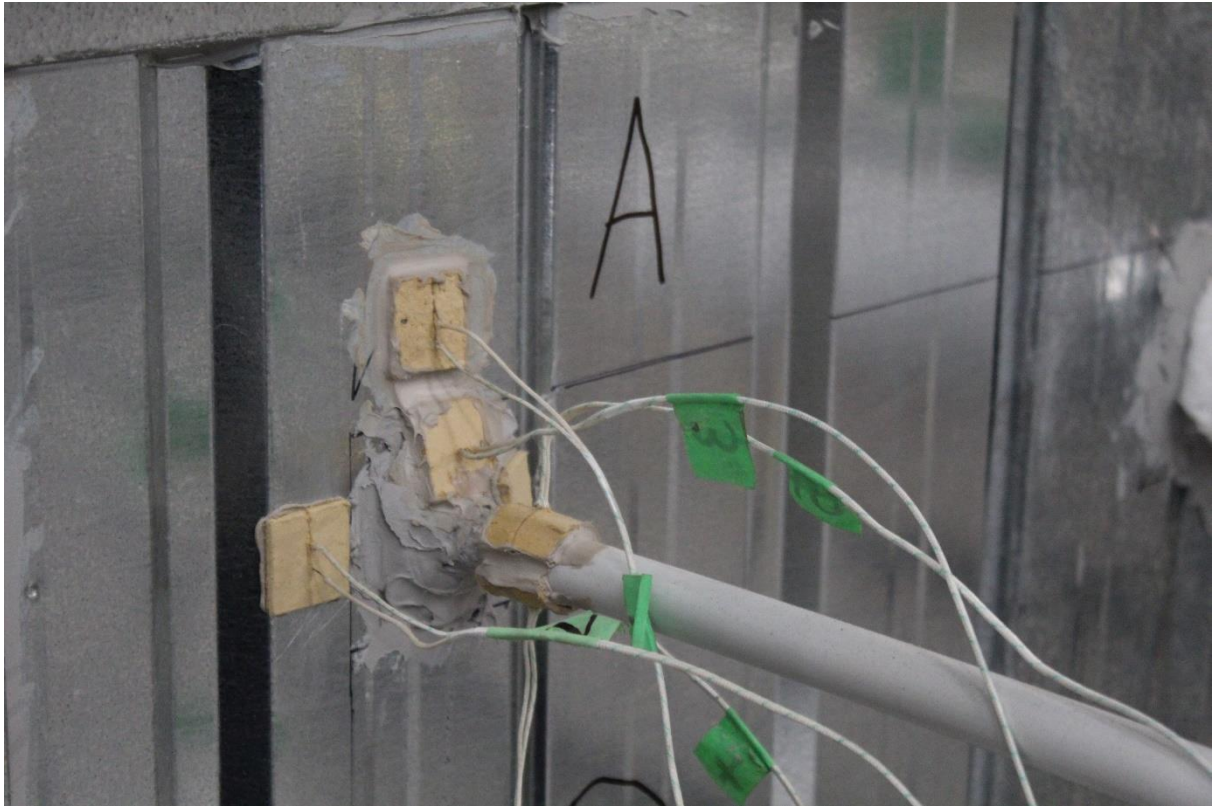
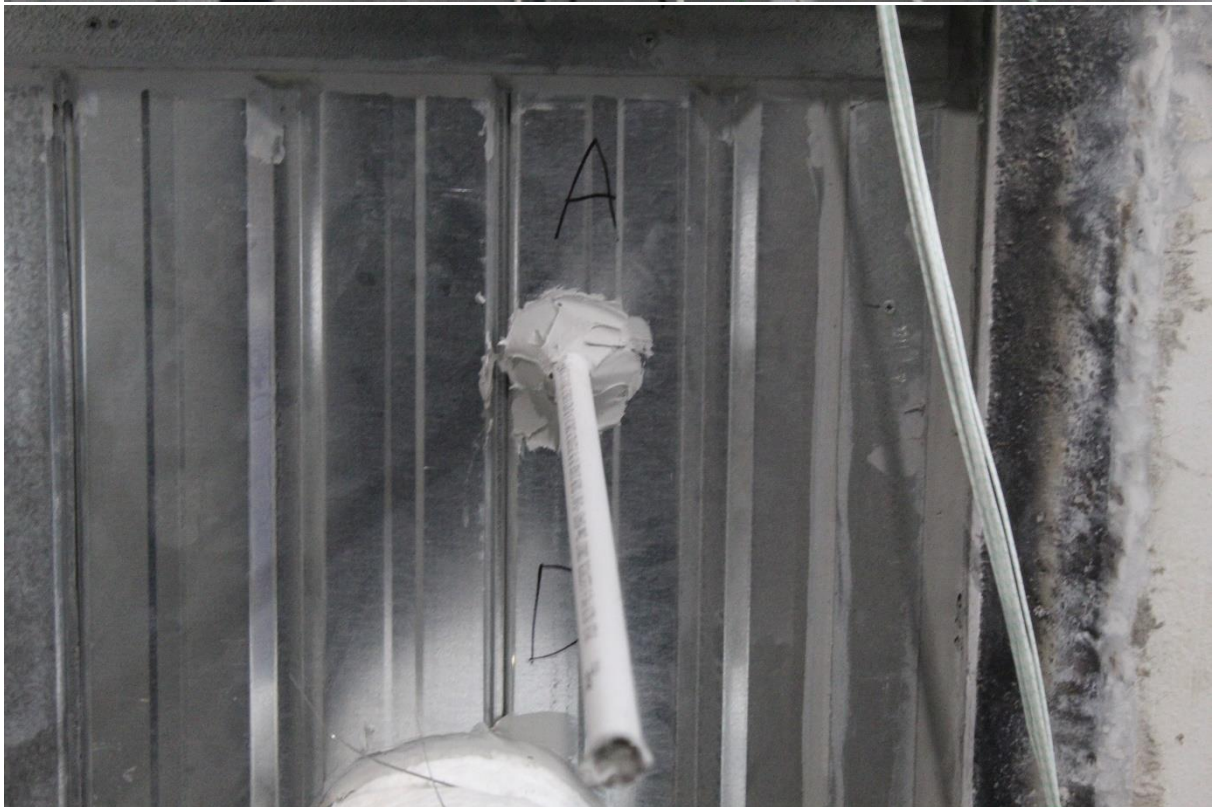
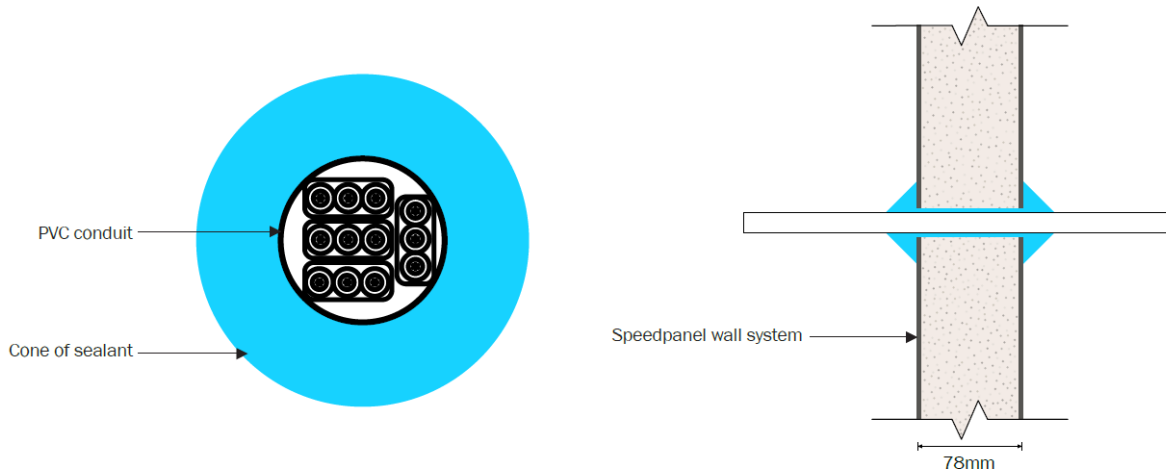
## 10.1 Specimen A

Penetration System		
A	Service	20mm PVC-U Pipe with Cables
	Service Details	Pipe (2.8), 1 x Cable (2.1), 2 x Cable (2.2), 3 x Cable (2.3), Sealant (3.1)
	Service Support	Unistrut structure at 500mm and 1500mm
	Aperture Size	32.19mm
	Annular Spacing	Min: 6mm, Max: 6mm
	<b>Local Fire-stopping Protection</b>	
Application	Symmetrical, capped from exposed face only	
Protection Used	<p>Aperture was cut into the separating element, 1 x Cable (2.1), 2 x Cable (2.2), and 3 x Cable (2.3) were bundled together and passed into the PVC-U pipe. PVC-U pipe (2.8) was passed through the aperture, extending 500mm from both faces.</p> <p>Sealant (3.1) was applied to full depth of the aperture, flush with the Speedpanel at the point of maximum thickness. Once cured, a 25mm (nominal) sealant cone was applied to both faces.</p> <p>An additional section of PVC-U pipe was glued to the unexposed side, extending the total length of the pipe to 2000mm.</p>

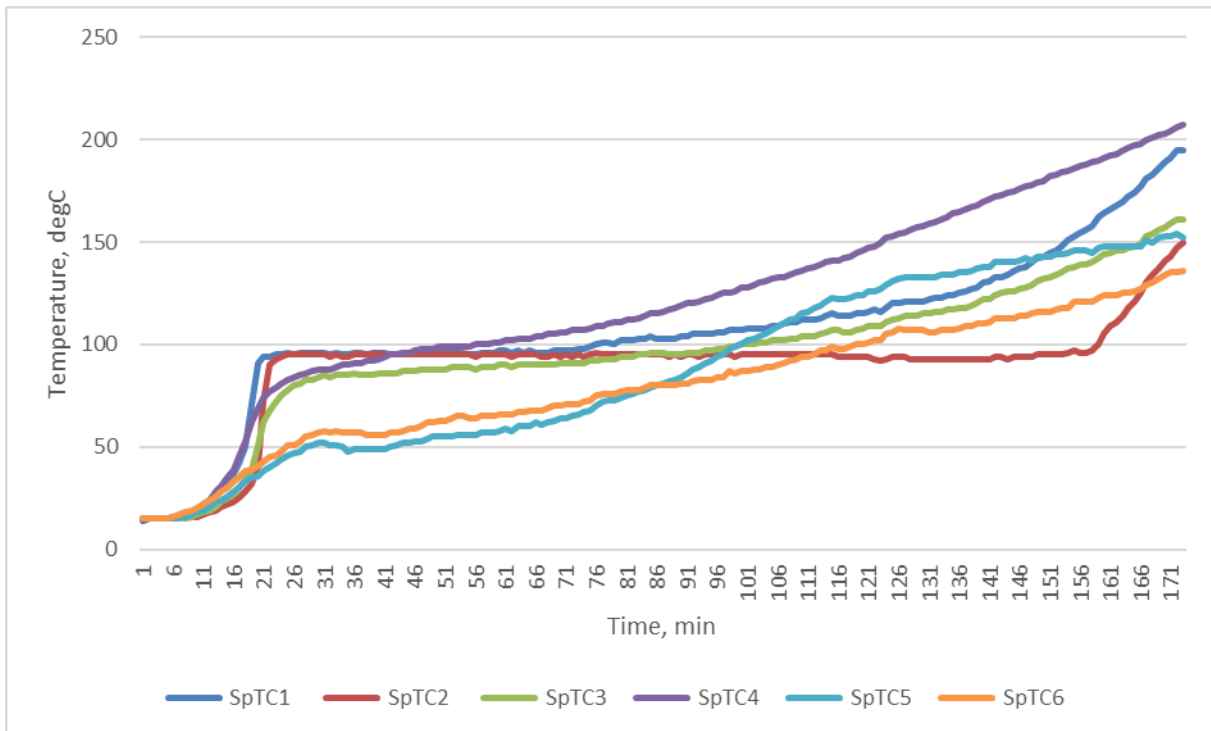
### Specimen A Thermocouples Readings

Structural adequacy	Not applicable
Integrity	No failure at 172 min
Insulation	162 min

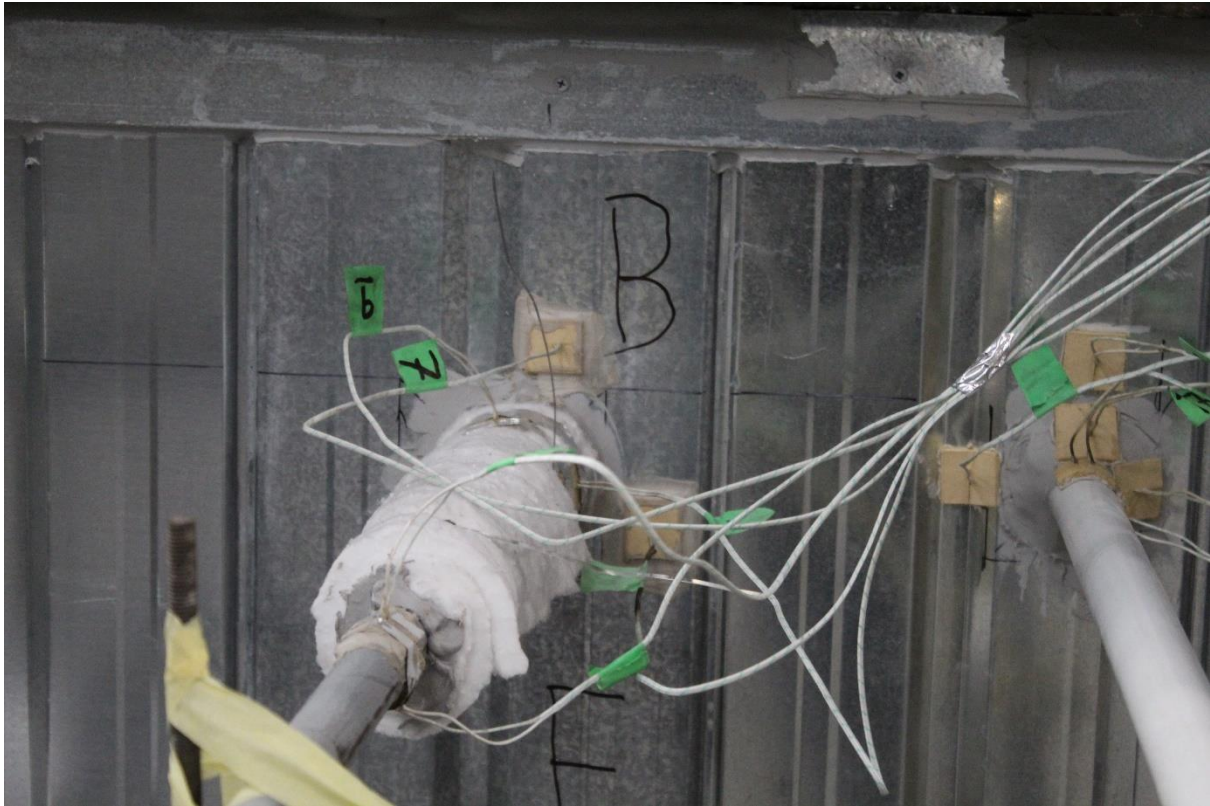
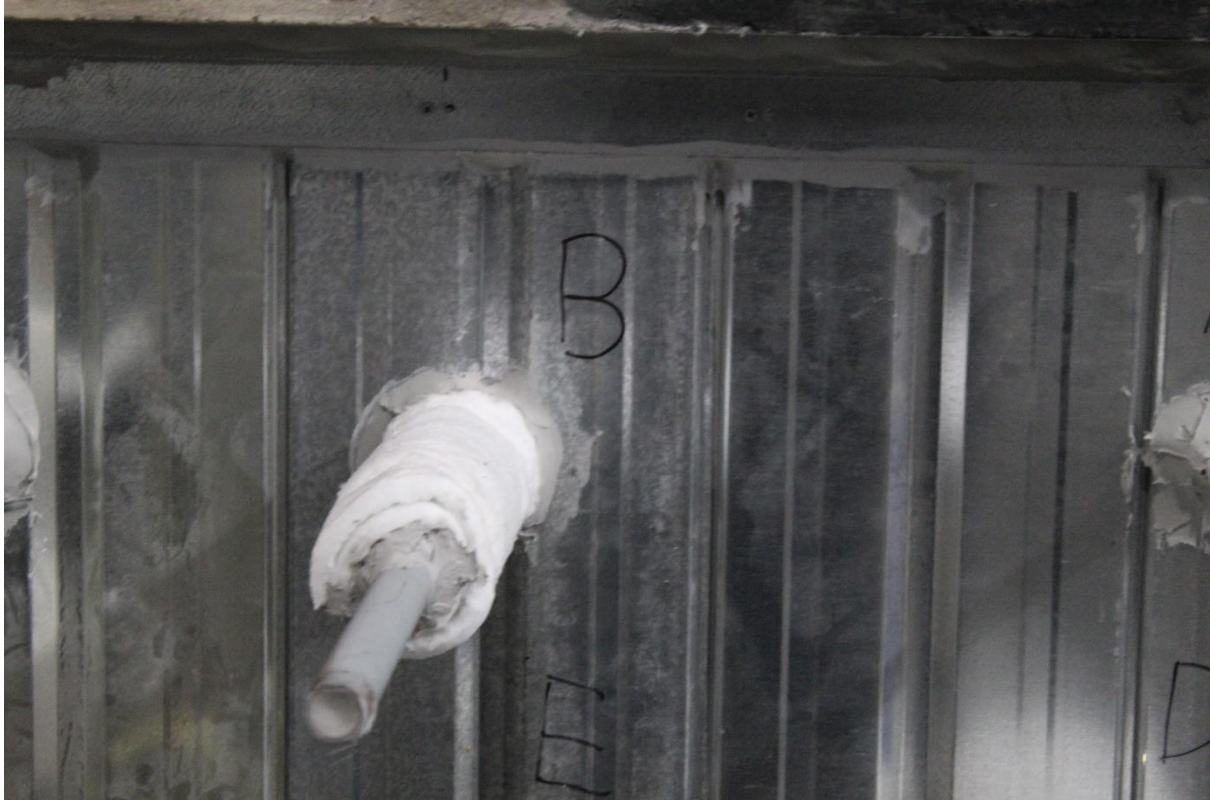
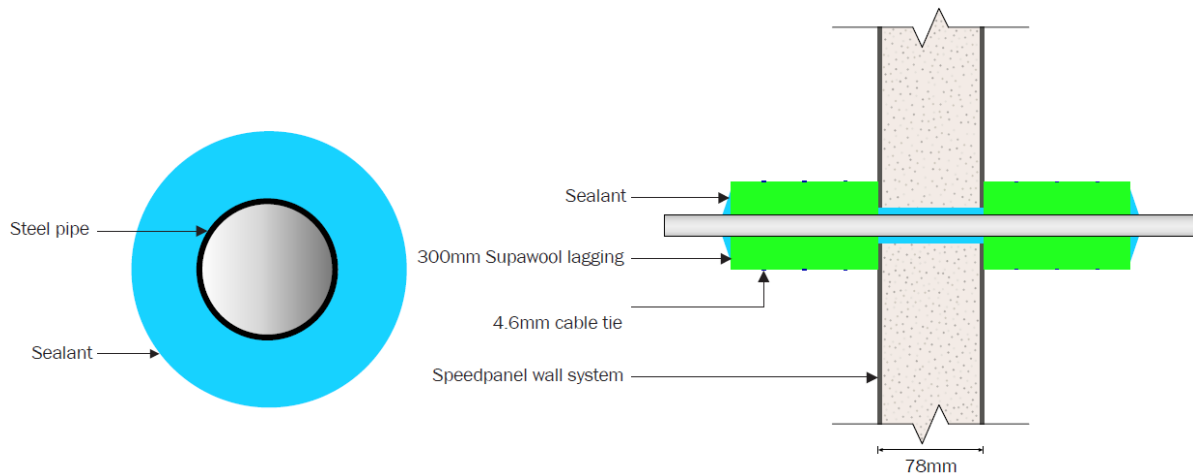
## 10.2 Specimen B

Penetration System		
B	Service	25DN Steel Pipe
	Service Details	Pipe (2.4), Sealant (3.1), Ceramic Fibre Blanket (5.1), Cable Ties (4.3)
	Service Support	Unistrut structure at 500mm
	Aperture Size	35.35mm
	Annular Spacing	Min: 3mm, Max: 6mm
	<b>Local Fire-stopping Protection</b>	
Application	Symmetrical, capped from exposed face only	
Protection Used	<p>Aperture was cut into the separating element, then the steel pipe (2.4) was passed through the aperture, extending 850mm from both faces.</p> <p>Sealant (3.1) was applied to full depth of the aperture, flush with the Speedpanel at the point of maximum thickness. A length of Ceramic fibre was cut and wrapped around the service 2 ¼ times. The ceramic fibre was secured using cable ties (4.3), and extended 610mm from both faces. A 25mm (nominal) radius bead of sealant was applied between the speedwall and ceramic fibre. Sealant was applied between the end of the ceramic fibre and the pipe to fill any remaining gaps.</p>

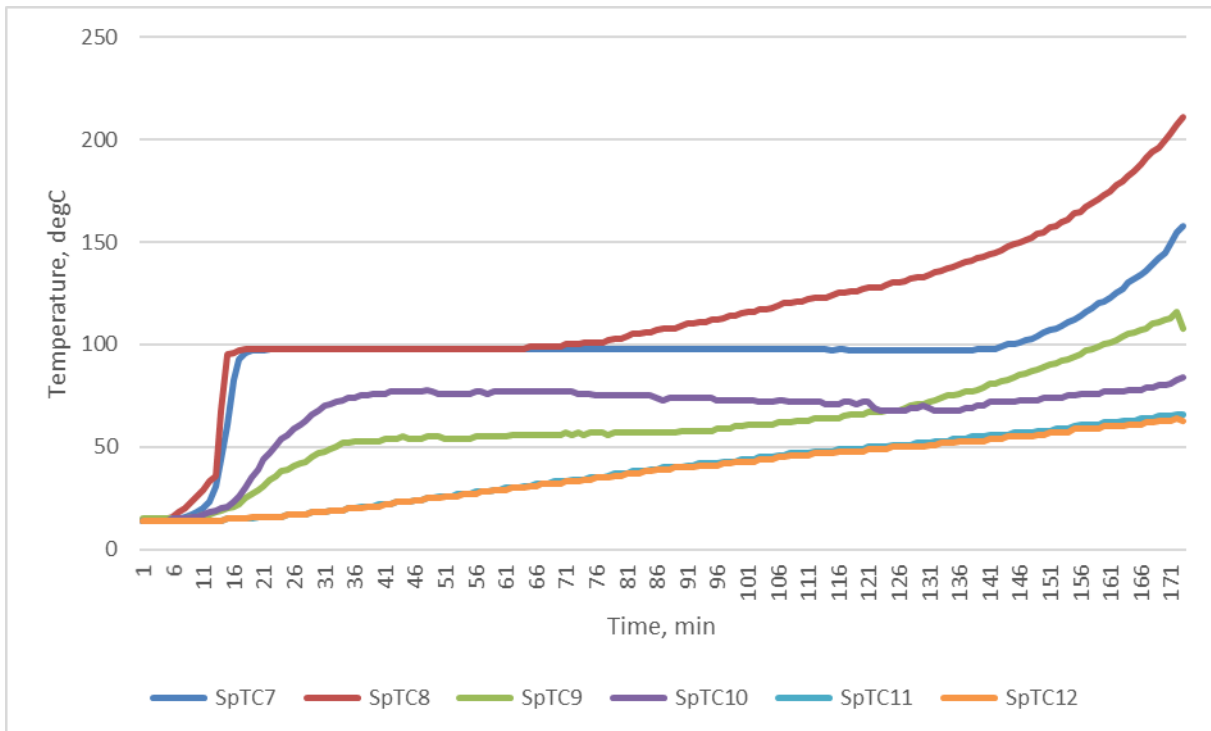
### Specimen B Thermocouples Readings

Structural adequacy	Not applicable
Integrity	No failure at 172 min
Insulation	167 min

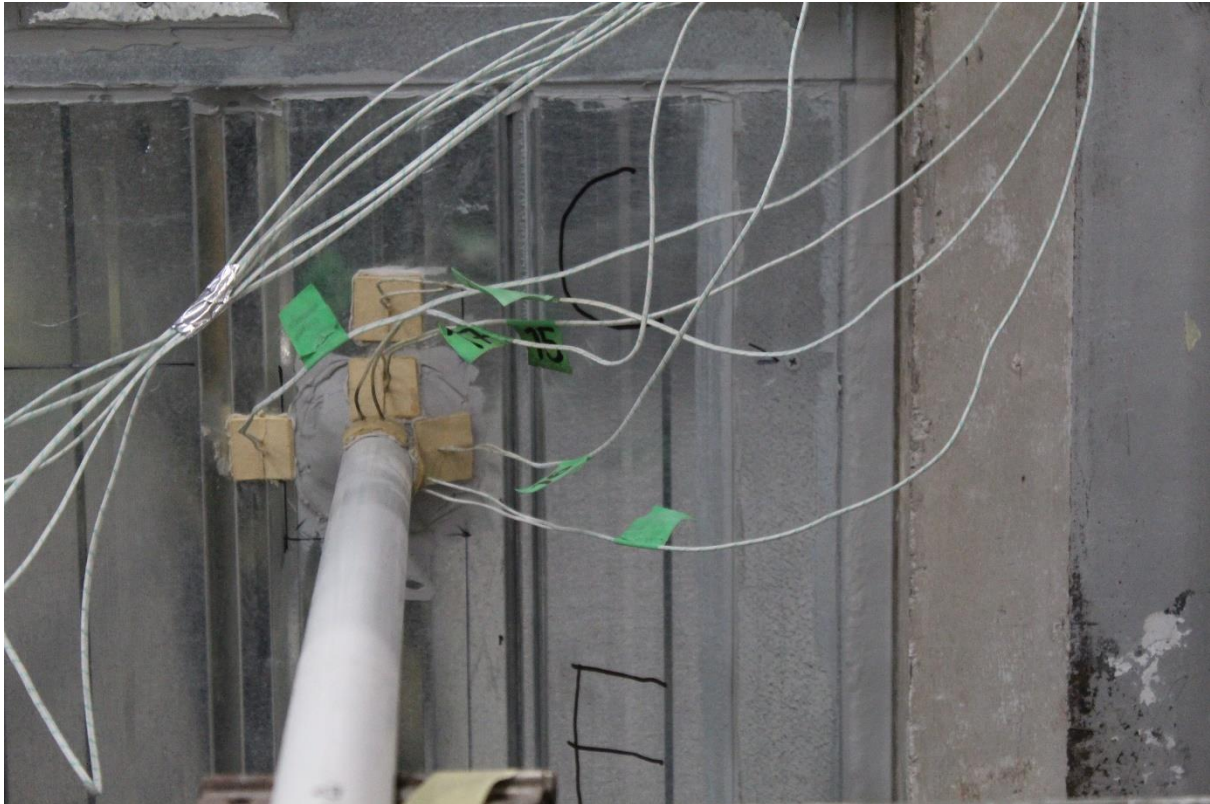
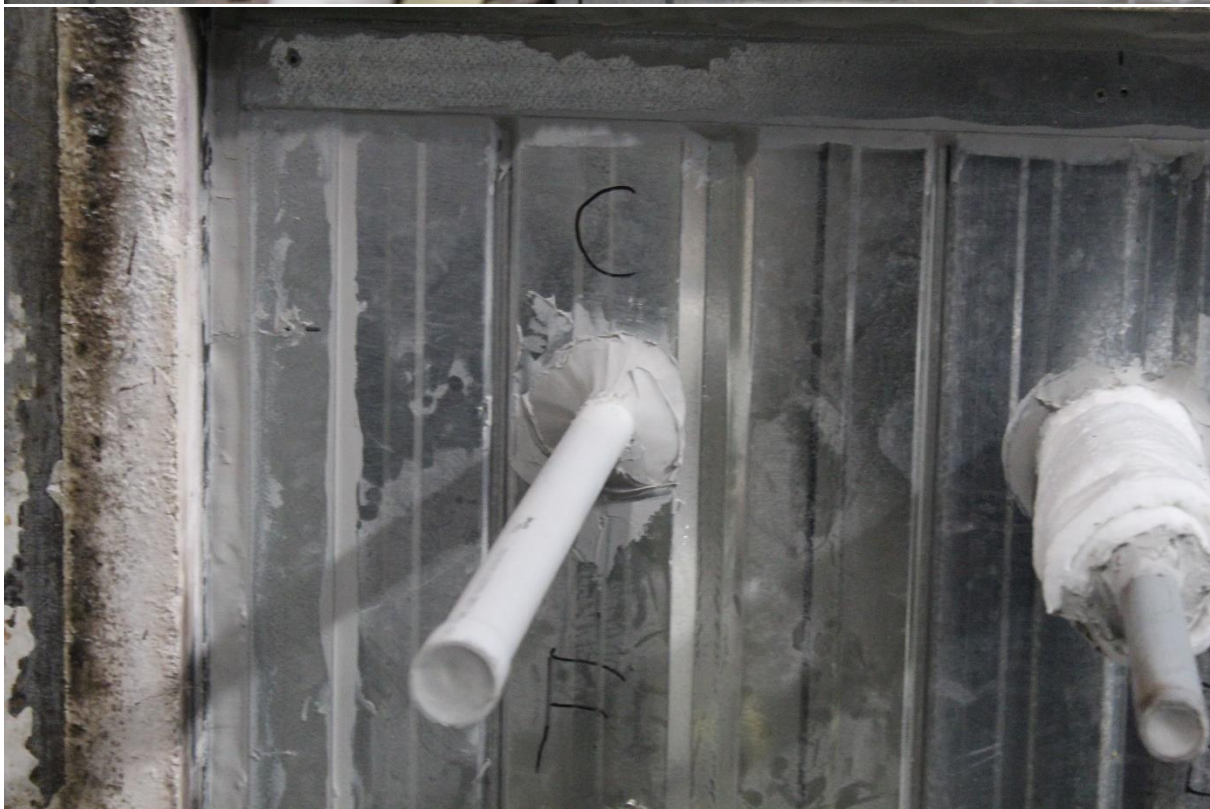
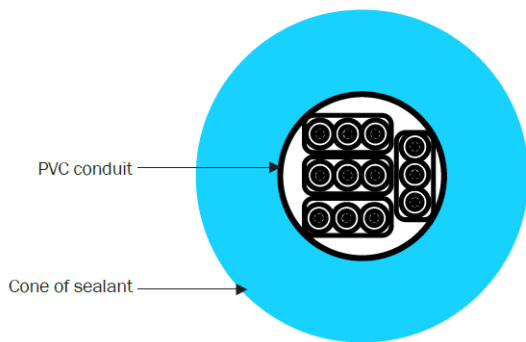
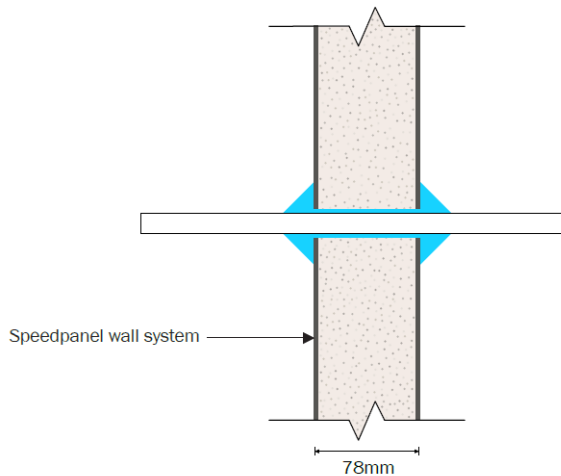
## 10.3 Specimen C

Penetration System		
C	Service	32mm PVC-U Pipe with Cables
	Service Details	Pipe (2.9), 3 x Cable (2.1), 3 x Cable (2.2), 3 x Cable (2.3), Sealant (3.1)
	Service Support	Unistrut structure at 500mm and 1500mm
	Aperture Size	43.77mm
	Annular Spacing	Min: 3mm, Max: 9mm
<b>Local Fire-stopping Protection</b>		
	Application	Symmetrical, capped from exposed face only
	Protection Used	<p>Aperture was cut into the separating element, 3 x Cable (2.1), 3 x Cable (2.2), and 3 x Cable (2.3) were bundled together and passed into the PVC-U pipe. PVC-U pipe (2.9) was passed through the aperture, extending 500mm from both faces.</p> <p>Sealant (3.1) was applied to full depth of the aperture, flush with the Speedpanel at the point of maximum thickness. Once cured, a 25mm (nominal) sealant cone was applied to both faces.</p> <p>An additional section of PVC-U pipe was glued to the unexposed side, extending the total length of the pipe to 2000mm.</p>

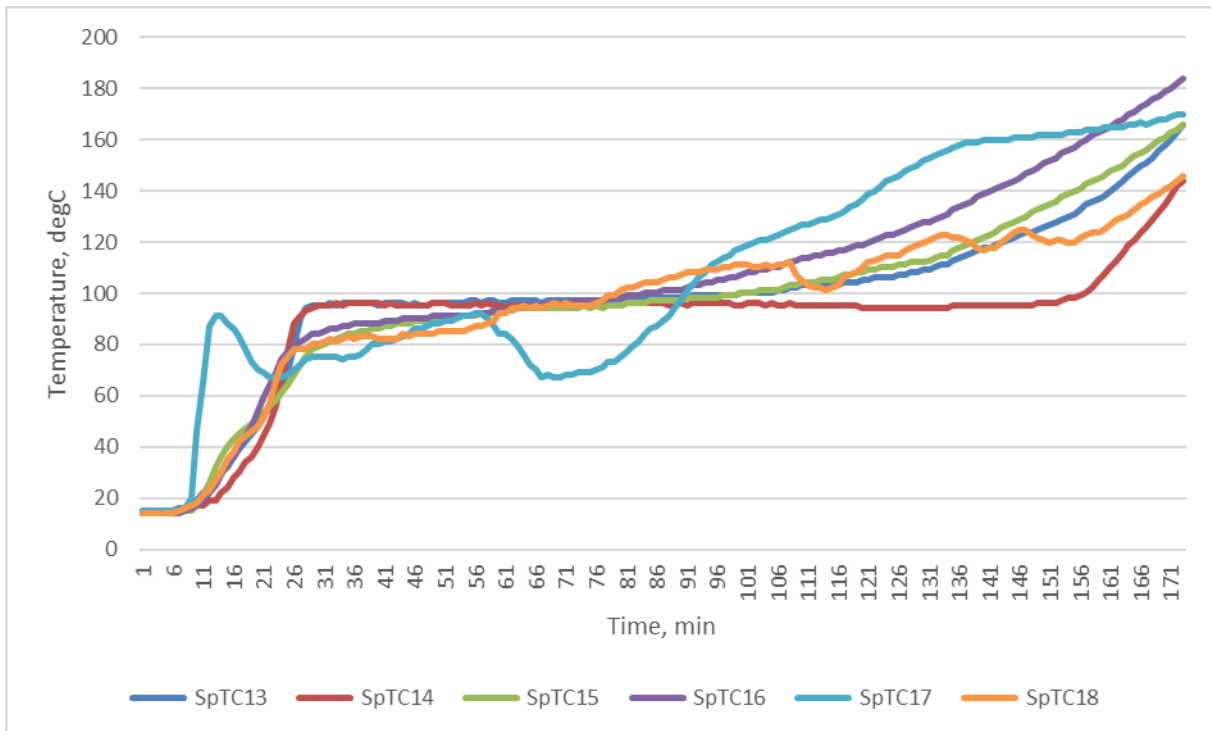
### Specimen C Thermocouples Readings

<b>Structural adequacy</b>	<b>Not applicable</b>
<b>Integrity</b>	<b>No failure at 172 min</b>
<b>Insulation</b>	<b>No failure at 172 min</b>

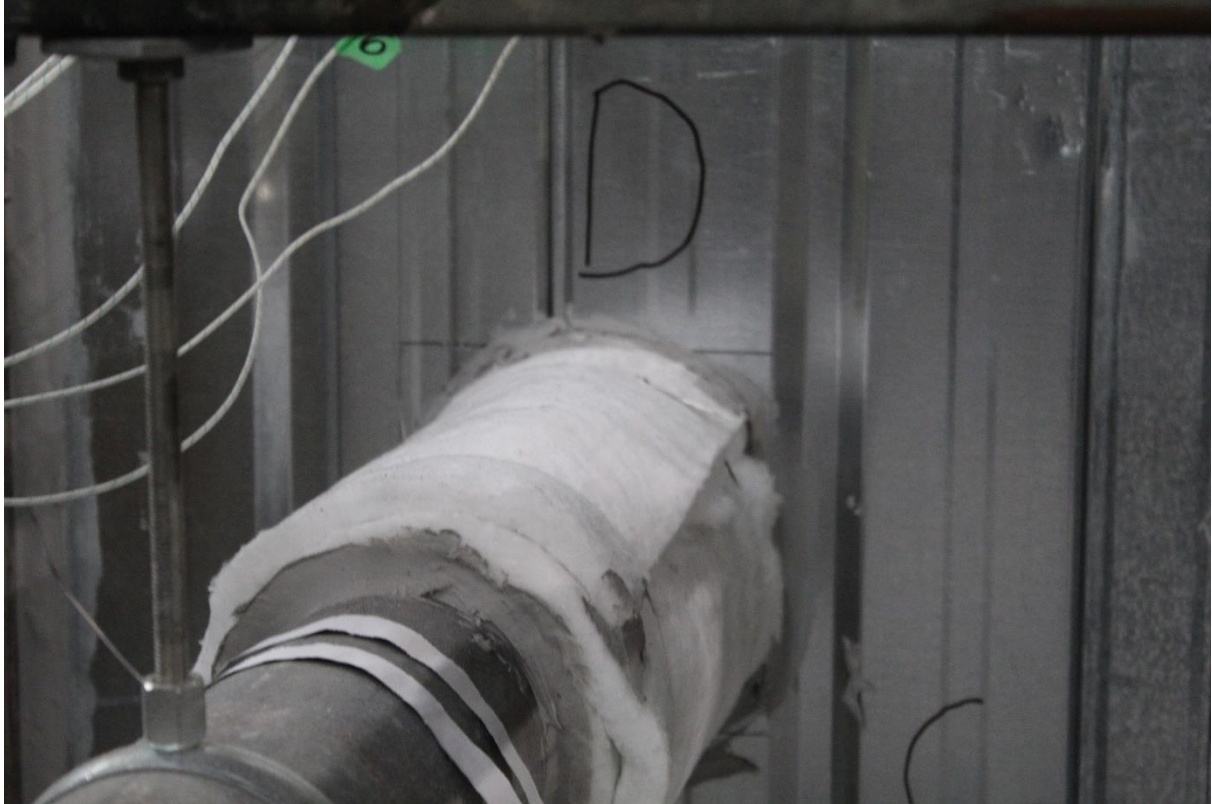
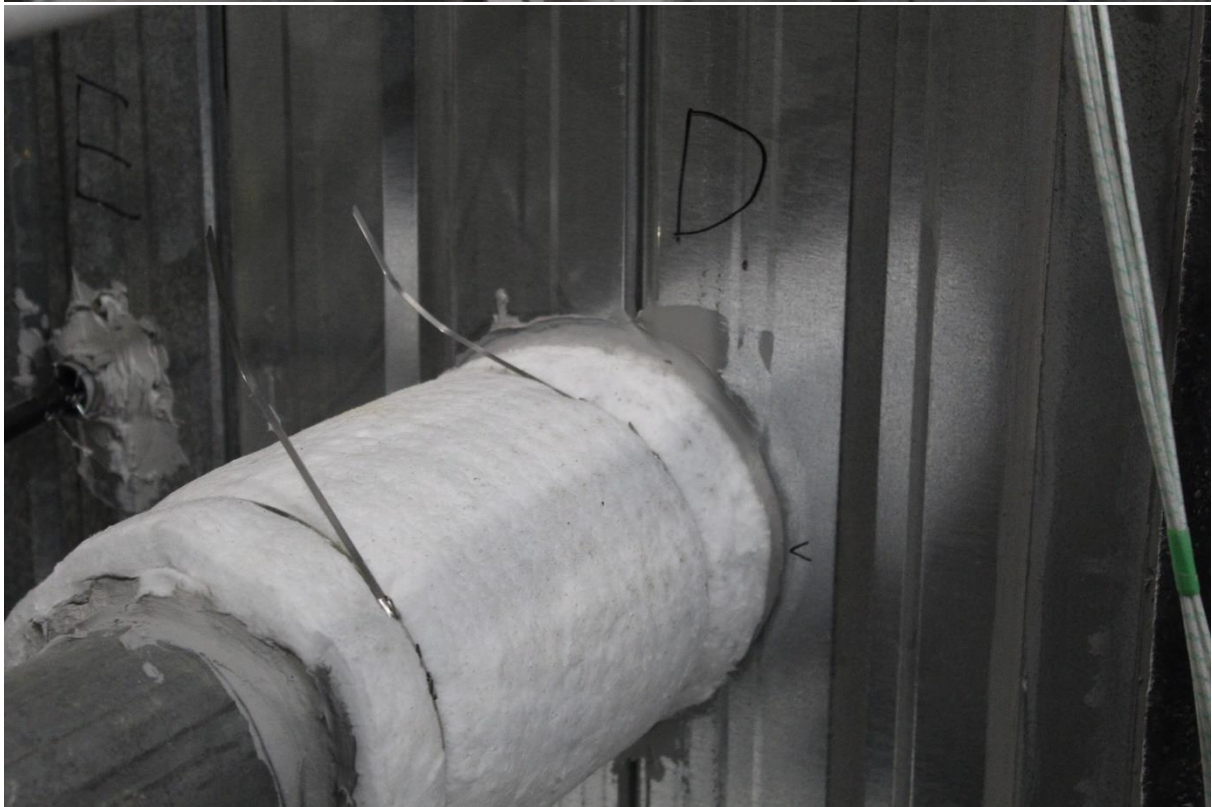
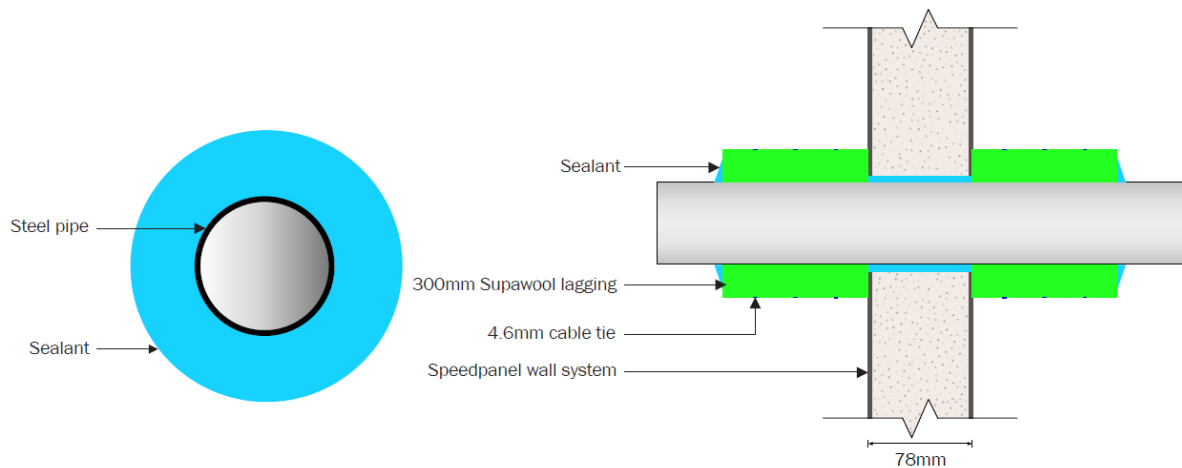
## 10.4 Specimen D

Penetration System		
D	Service	100DN Steel Pipe
	Service Details	Pipe (2.5), Sealant (3.1), Ceramic Fibre Blanket (5.1)
	Service Support	Unistrut structure at 500mm
	Aperture Size	142.37mm
	Annular Spacing	Min: 8mm, Max: 20mm
<b>Local Fire-stopping Protection</b>		
Application	Symmetrical, capped from exposed face only	
Protection Used	<p>Aperture was cut into the separating element, then the steel pipe (2.5) was passed through the aperture, extending 850mm from both faces.</p> <p>Sealant (3.1) was applied to full depth of the aperture, flush with the Speedpanel at the point of maximum thickness. A length of Ceramic fibre was cut and wrapped around the service 2 ¼ times. The ceramic fibre was secured using cable ties (4.3), and extended 610mm from both faces. A 25mm (nominal) radius bead of sealant was applied between the speedwall and ceramic fibre. Sealant was applied between the end of the ceramic fibre and the pipe to fill any remaining gaps.</p>

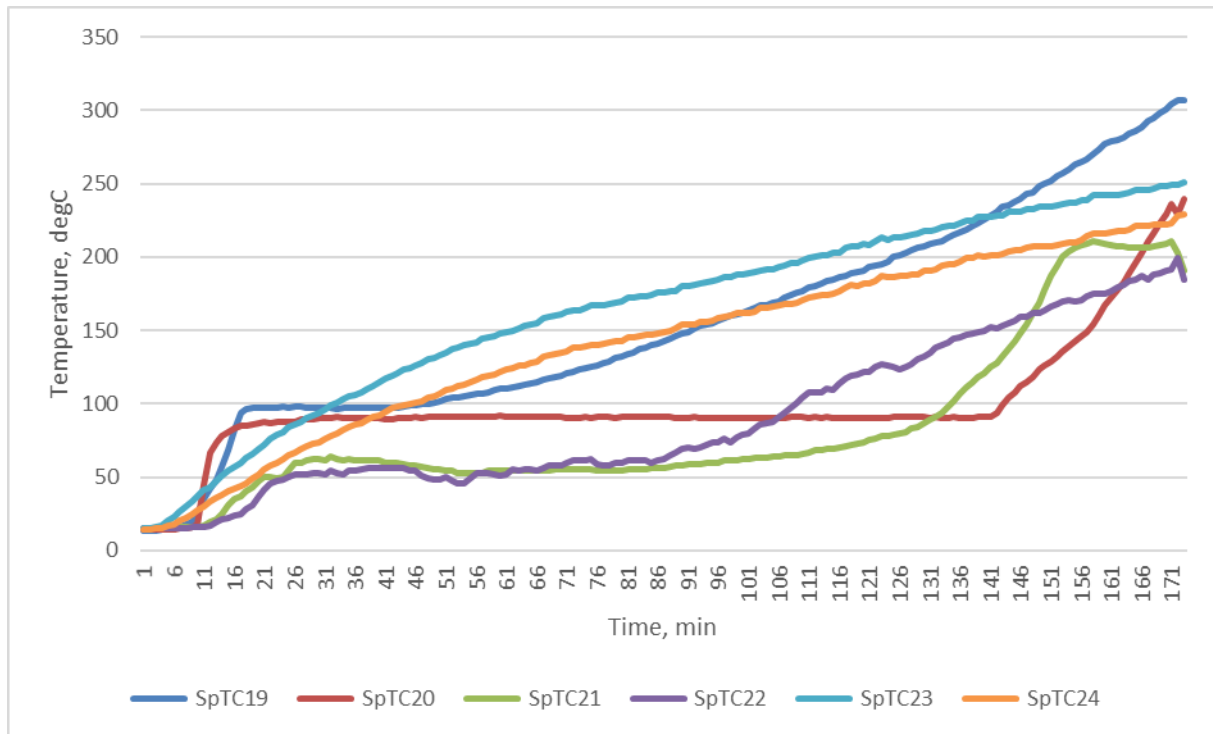
### Specimen D Thermocouples Readings

Structural adequacy	Not applicable
Integrity	No failure at 172 min
Insulation	107 min

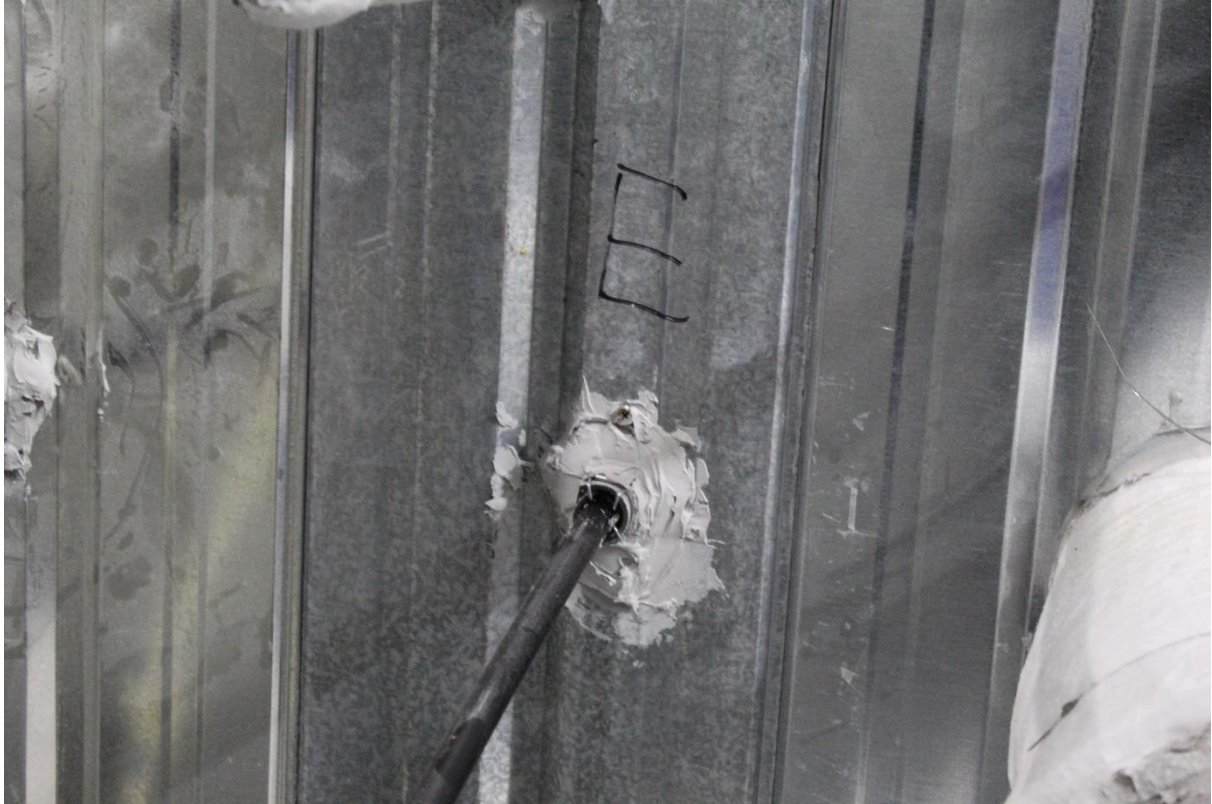
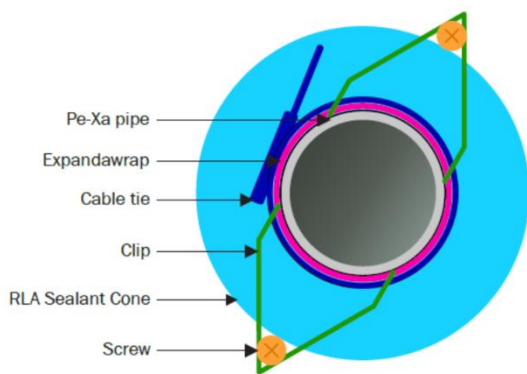
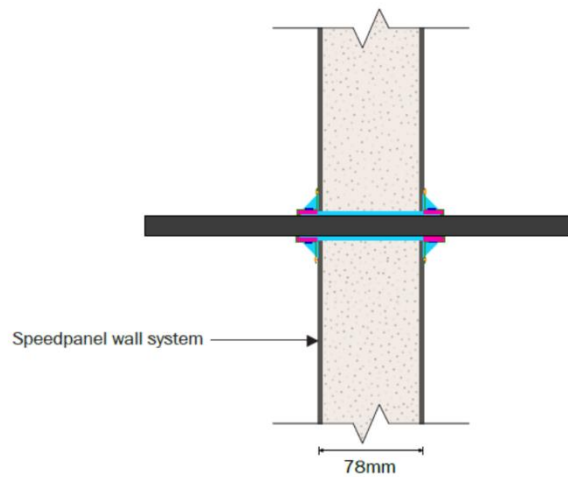
## 10.5 Specimen E

Penetration System		
E	Service	16DN Pe-Xa Pipe
	Service Details	Pipe (2.7), Sealant (3.1), Intumescent Strip (5.2), Steel Wire Clips (4.3), Screws (4.1)
	Service Support	Unistrut structure at 500mm and 1500mm
	Aperture Size	29.13mm
	Annular Spacing	Min: 1mm, Max: 12mm
	<b>Local Fire-stopping Protection</b>	
	Application	Symmetrical, capped from exposed face only
	Protection Used	Aperture was cut into the separating element, then Pe-Xa pipe (2.7) was passed through the aperture, extending 500mm from the exposed face, and 2000mm from the unexposed face  Sealant (3.1) was applied to full depth of the aperture, flush with the Speedpanel at the point of maximum thickness. A length of Intumescent strap (5.2) was cut to wrap around the pipe one time, with approximately 10mm overlap. The strap was fixed to the separating element using two steel wire clips (4.4) and screws (4.1). A 25mm (nominal) radius bead of sealant was applied between the intumescent strip and the separating element.

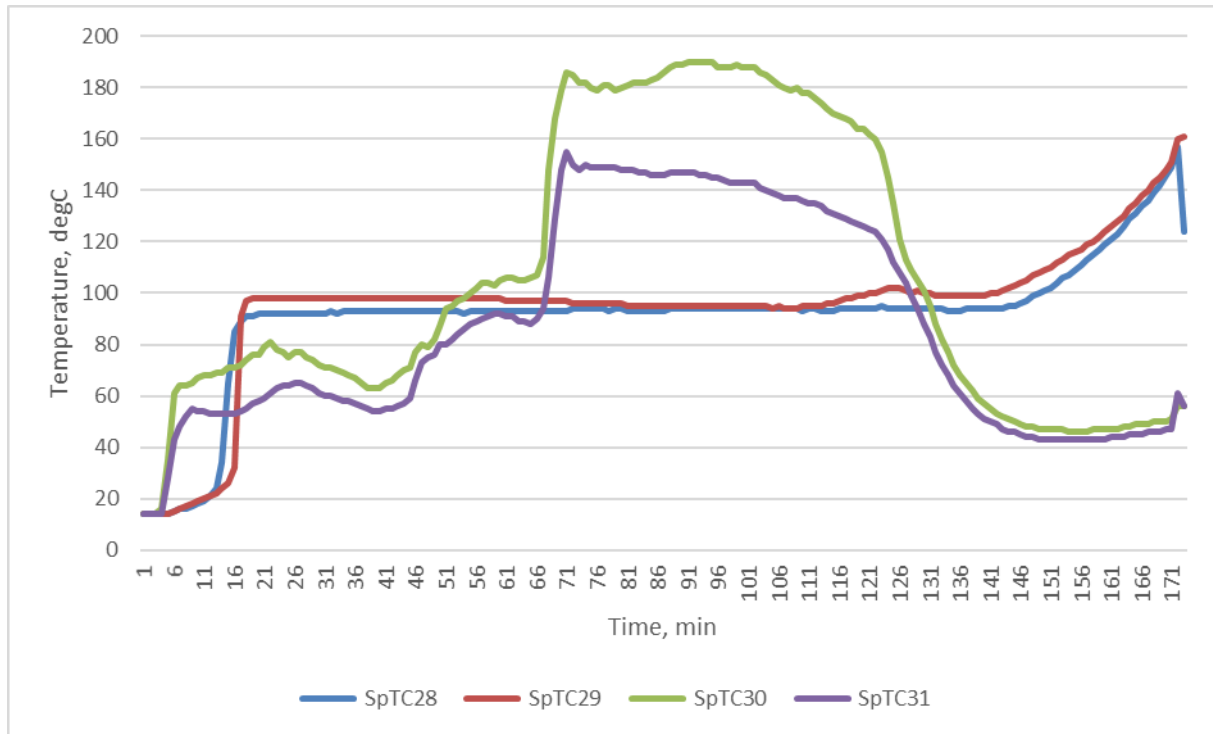
## Specimen E Thermocouples Readings

<b>Structural adequacy</b>	<b>Not applicable</b>
<b>Integrity</b>	<b>No failure at 172 min</b>
<b>Insulation</b>	<b>No failure at 172 min</b>

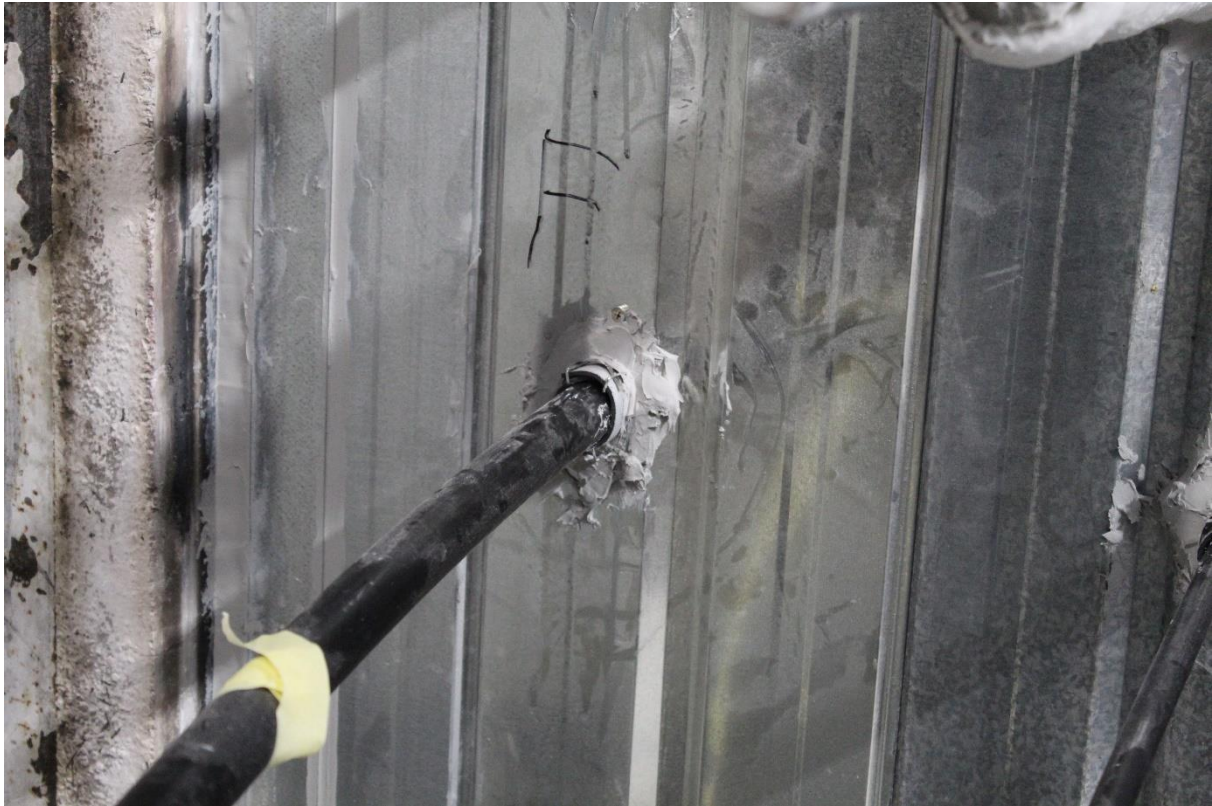
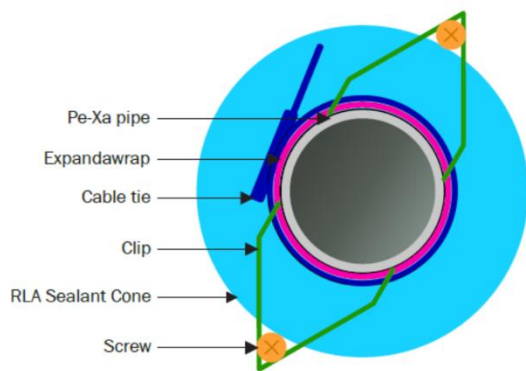
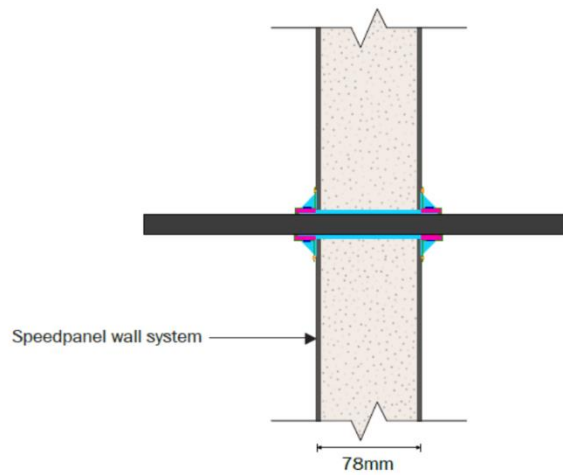
## 10.6 Specimen F

Penetration System		
F	Service	32DN Pe-Xa Pipe
	Service Details	Pipe (2.6), Sealant (3.1), Intumescent Strip (5.2), Steel Wire Clips (4.3), Screws (4.1)
	Service Support	Unistrut structure at 500mm and 1500mm
	Aperture Size	44.31mm
	Annular Spacing	Min: 3mm, Max: 9mm
	<b>Local Fire-stopping Protection</b>	
Application	Symmetrical, capped from exposed face only	
Protection Used	<p>Aperture was cut into the separating element, then Pe-Xa pipe (2.6) was passed through the aperture, extending 500mm from the exposed face, and 2000mm from the unexposed face</p> <p>Sealant (3.1) was applied to full depth of the aperture, flush with the Speedpanel at the point of maximum thickness. A length of Intumescent strap (5.2) was cut to wrap around the pipe one time, with approximately 10mm overlap. The strap was fixed to the separating element using two steel wire clips (4.4) and screws (4.1). A 25mm (nominal) radius bead of sealant was applied between the intumescent strip and the separating element.</p>

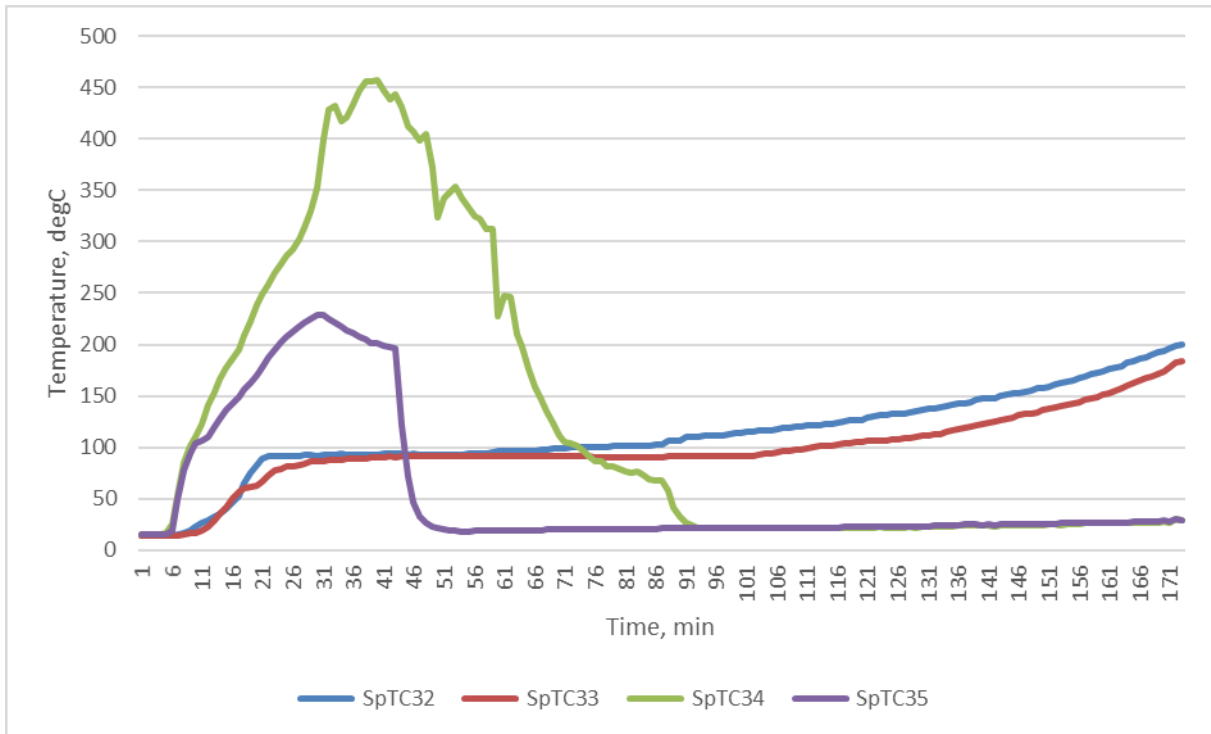
## Specimen F Thermocouples Readings

<b>Structural adequacy</b>	<b>Not applicable</b>
<b>Integrity</b>	<b>No failure at 172 min</b>
<b>Insulation</b>	<b>16 min</b>
