## **Test report # PF21008-A**

**Fire resistance tests for wall penetrations**

**Test method: AS 1530.4:2014**

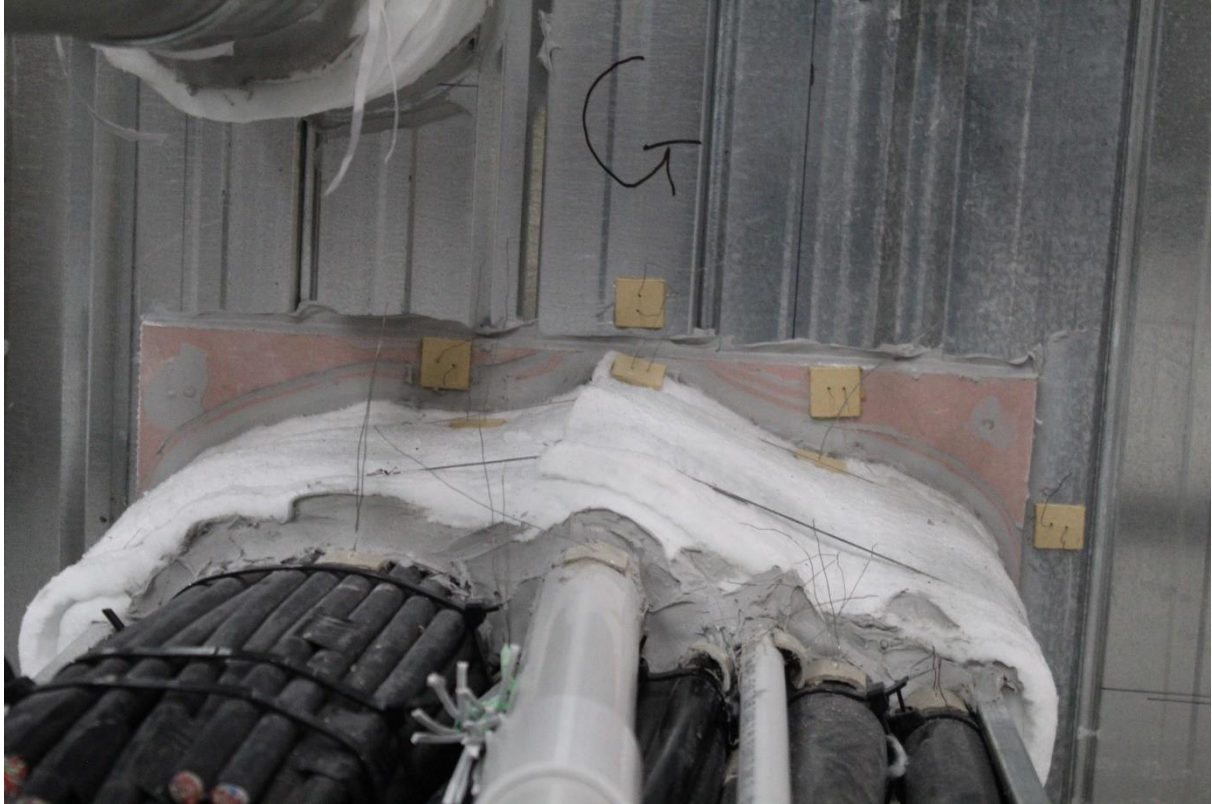
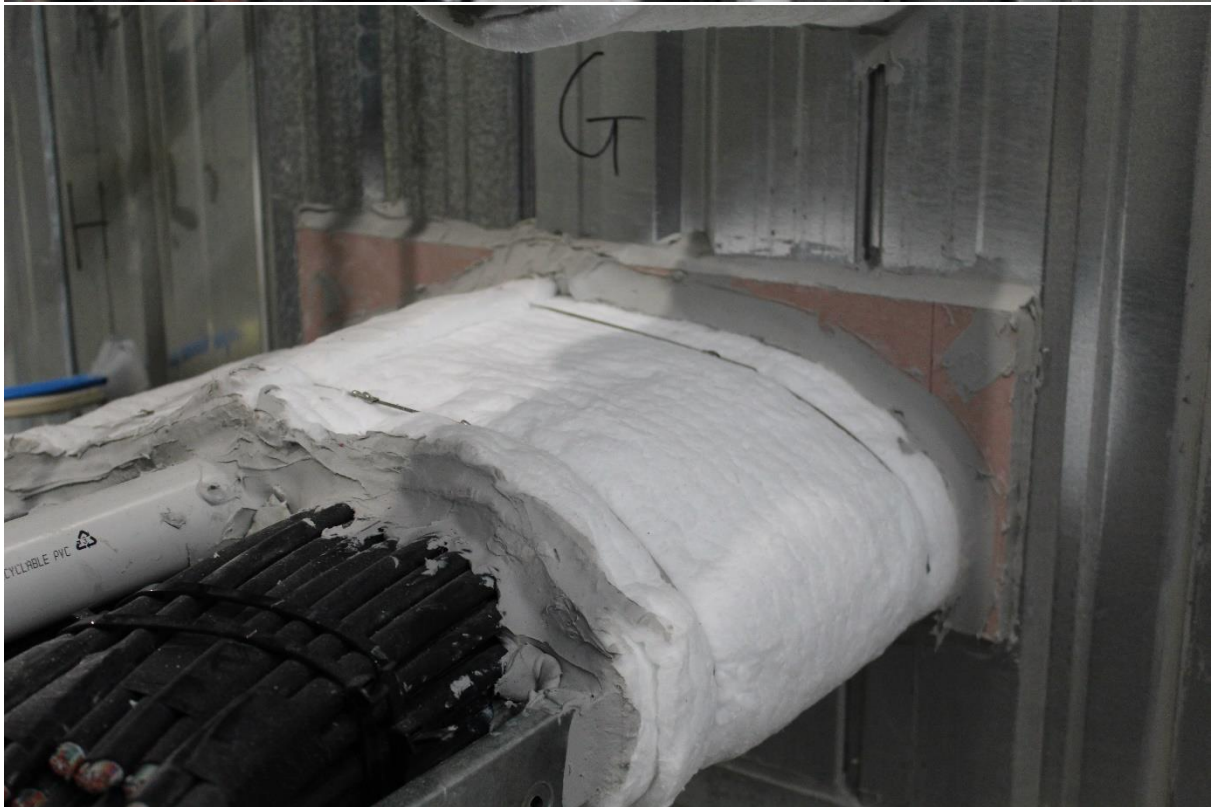
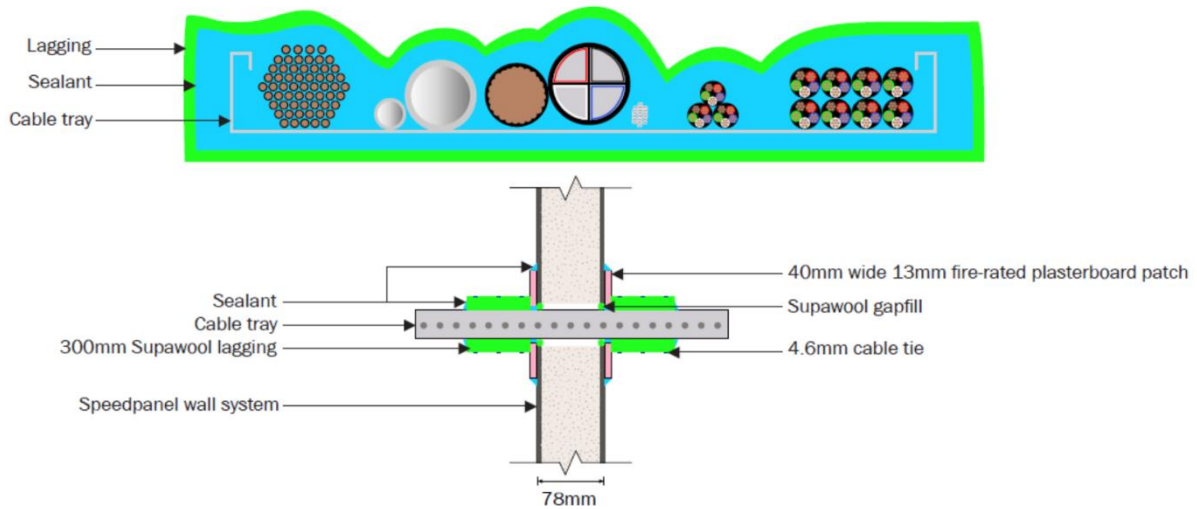
## 10.7 Specimen G

Penetration System		
G	Service	D1 and D2 cable configuration with plastic pipe and Cable Bundle on the Cable Tray
	Service Details	Cable Tray (2.11), Pipe (2.8), Pipe (2.10), 11 x Cable (2.1), 32 x Cable (2.2), 13 x Cable (2.3), 1 x Cable (2.12), 1 x Cable (2.13), 3 x Cable (2.14), 8 x Cable (2.15), 60 x Cable (2.16), Ceramic Fibre Blanket (5.1), Cable ties (4.3) Sealant (3.1), Plasterboard (5.3). Cable configurations and additional services were put together upon the request of Client.
	Service Support	Unistrut structure at 500mm
	Aperture Size	465mm x 115mm
	Annular Spacing	Min: 1mm, Max: 60mm
	<b>Local Fire-stopping Protection</b>	
Application	Symmetrical, capped from exposed face only	
Protection Used	Aperture cut into the separating element. The 60 x D2 Cables (2.16) were bundled using cable ties and placed on the unexposed left side of the cable tray (2.11). The D1 Cable configuration was placed next to the D2 configuration in the order of 8 x Cable (2.15), 3 x Cable (2.14), 1 x Cable (2.13), then 1 x Cable (2.12). The cables were secured to the cable tray with cable ties. The Cable tray was placed through the aperture.  10 x Cable (2.1), 10 x Cable (2.2), and 10 x Cable (2.3) were bundled together and placed in the pipe (2.10).

<p>1 x Cable (2.1), 2 x Cable (2.2), and 3 x Cable (2.3) were bundled together and placed in the pipe (2.8). 20 x Cable (2.2) were bundled together.</p> <p>The cable bundle was placed between the D1 and D2 configurations on the cable tray. The pipe (2.8) was placed on top of the D1 configuration between the 8 x Cable (2.15) and the 3 x Cable (2.14). The pipe (2.10) was placed between the D1 and D2 configurations on top of the additional cable bundle. The additional pipes and cable bundle extended 500mm from both faces.</p> <p>Sections of ceramic fibre blanket (5.1) were cut and pushed into the aperture gaps around the perimeter of the cable bundle, recessed 13mm into the separating element. A section of plasterboard (5.3) was cut to follow the profile of the cable tray and was fixed to the separating element with screws (4.3). This resulted in a maximum aperture gap of approximately 20mm, and a minimum aperture gap of 2mm. A bead of sealant was applied to the perimeter junction between plasterboard and Speedpanel, and the ceramic fibre recess within the aperture was filled with sealant, resulting in a thickness of 30mm (nominal). Sealant was applied flush with the additional plasterboard layer. Once cured, a 25mm (nominal) radius bead of sealant was applied between the plasterboard and the cable tray around the perimeter.</p> <p>The outside of the cable tray was wrapped with two and a half revolutions of ceramic fibre blanket. The end of the blanket measured 300mm from the separating element. The ceramic blanket was secured to the cable tray using cable ties (4.3). The remaining gaps between the cable tray and ceramic blanket were filled using more ceramic blanket.</p> <p>A 25mm (nominal) radius bead of sealant was applied between the plasterboard and the ceramic blanket around the perimeter. The PVC pipes were extended to 2000mm from the unexposed face by gluing another length to the existing pipes.</p>

167	U	SE	Visible smoke from top right perimeter junction
170	U	G	Visible flaming for more than 10 seconds – Integrity failure – Specimen G ignited on the unexposed side and consequently speed panel lost integrity at the joint
172			TEST DISCONTINUED

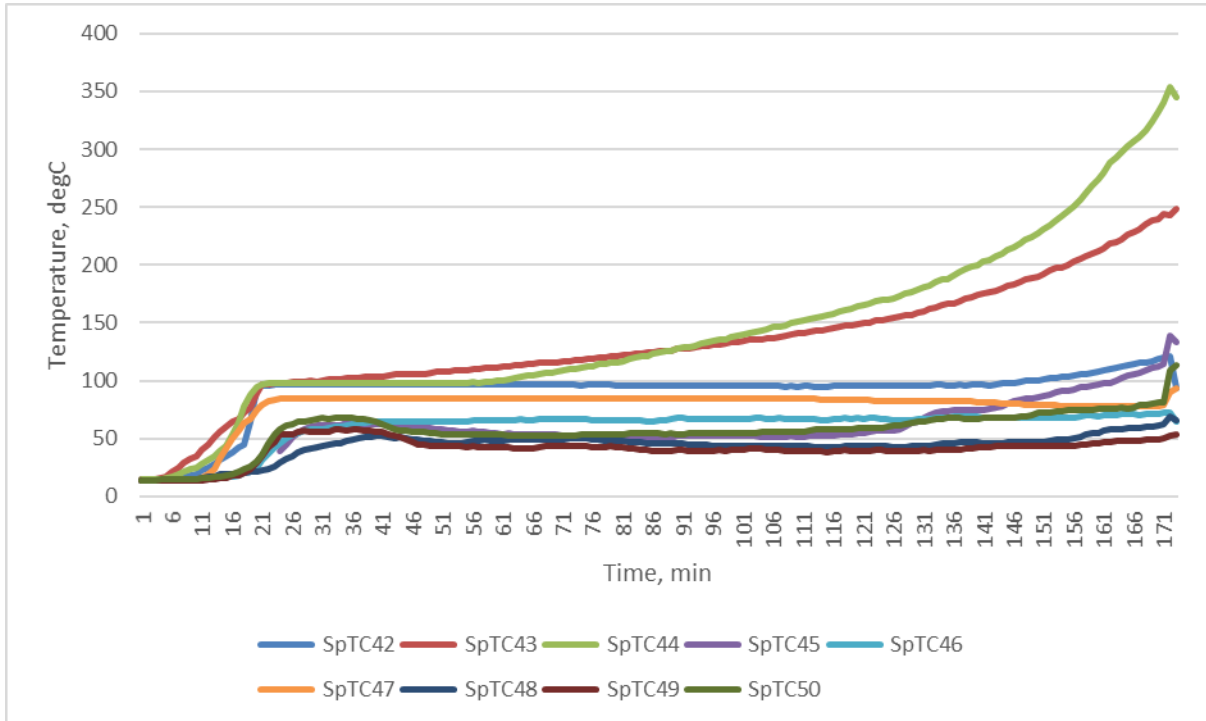
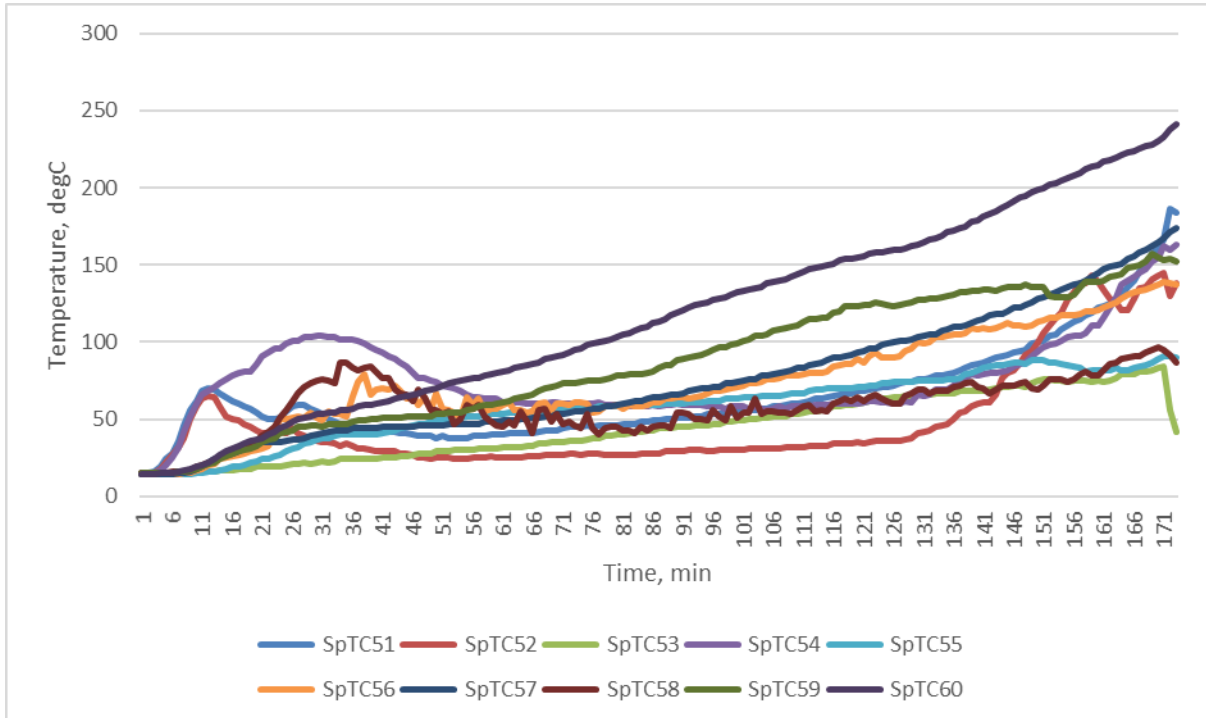
## Specimen G Thermocouples Readings

<b>Structural adequacy</b>	<b>Not applicable</b>
<b>Integrity</b>	<b>170 min</b>
<b>Insulation</b>	<b>137 min</b>

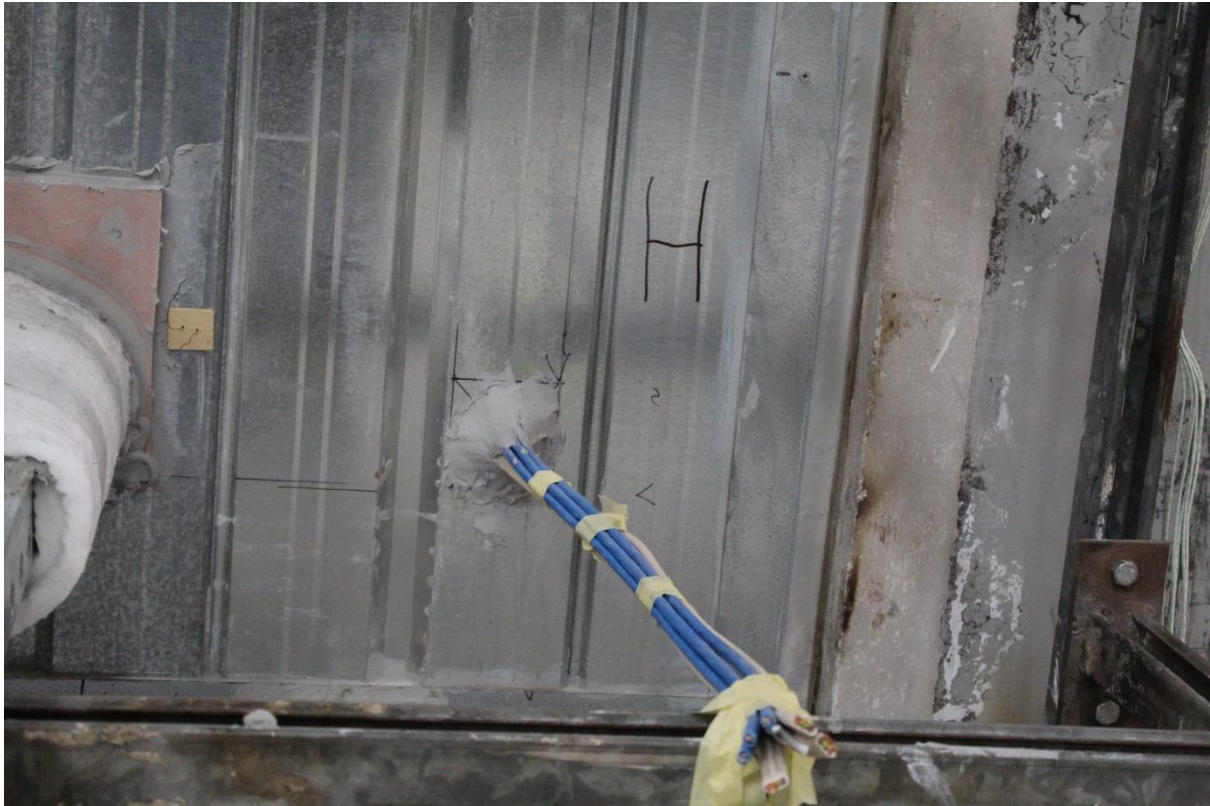
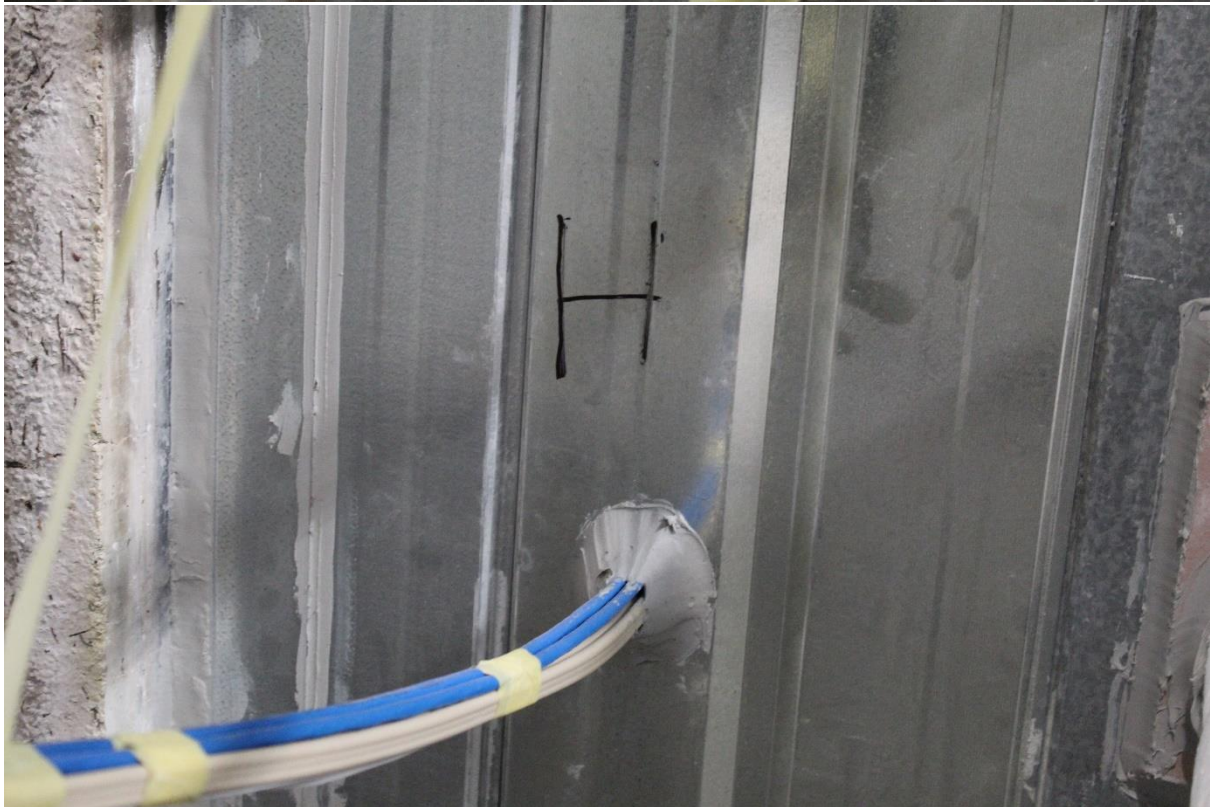
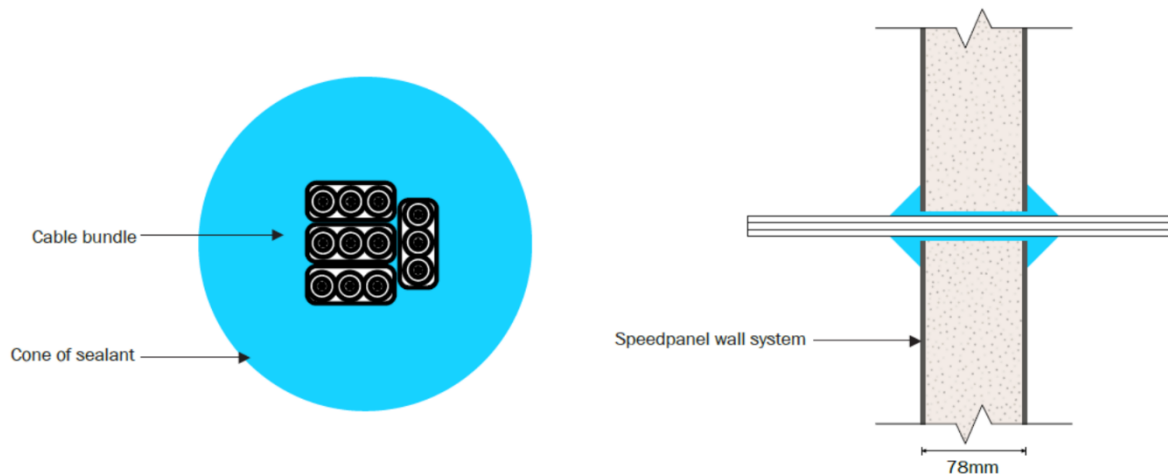
## 10.8 Specimen H

Penetration System		
H	Service	20mm Cable Bundle
	Service Details	3 x Cable (2.1), 3 x Cable (2.2), 3 x Cable (2.3), Sealant (3.1)
	Service Support	Unistrut structure at 500mm and 1500mm
	Aperture Size	41.79mm
	Annular Spacing	Min: 4mm, Max: 14mm
	<b>Local Fire-stopping Protection</b>	
Application	Symmetrical	
Protection Used	<p>Aperture was cut into the separating element, 3 x Cable (2.1), 3 x Cable (2.2), and 3 x Cable (2.3) were bundled together and passed through the aperture, extending 500mm from both faces.</p> <p>Sealant (3.1) was applied to full depth of the aperture, flush with the Speedpanel at the point of maximum thickness. Once cured, a 25mm (nominal) sealant cone was applied to both faces.</p>

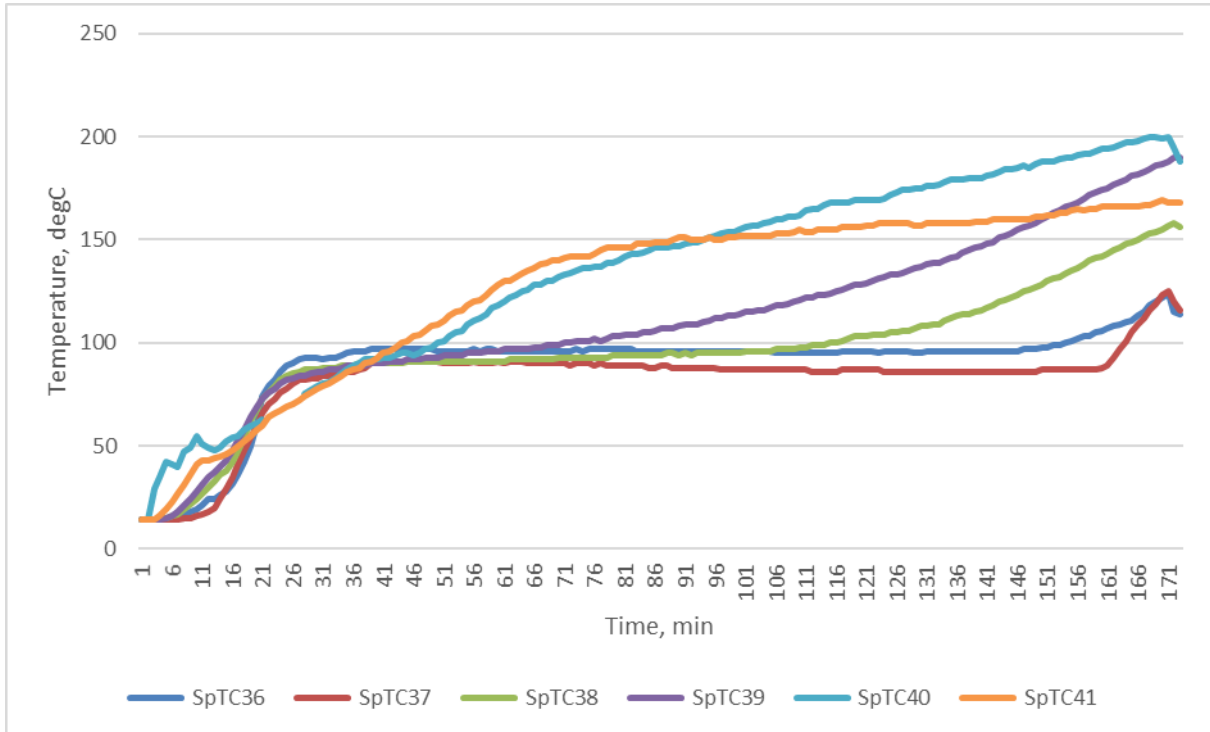
## Specimen H Thermocouples Readings

Structural adequacy	Not applicable
Integrity	No failure at 172 min
Insulation	161 min

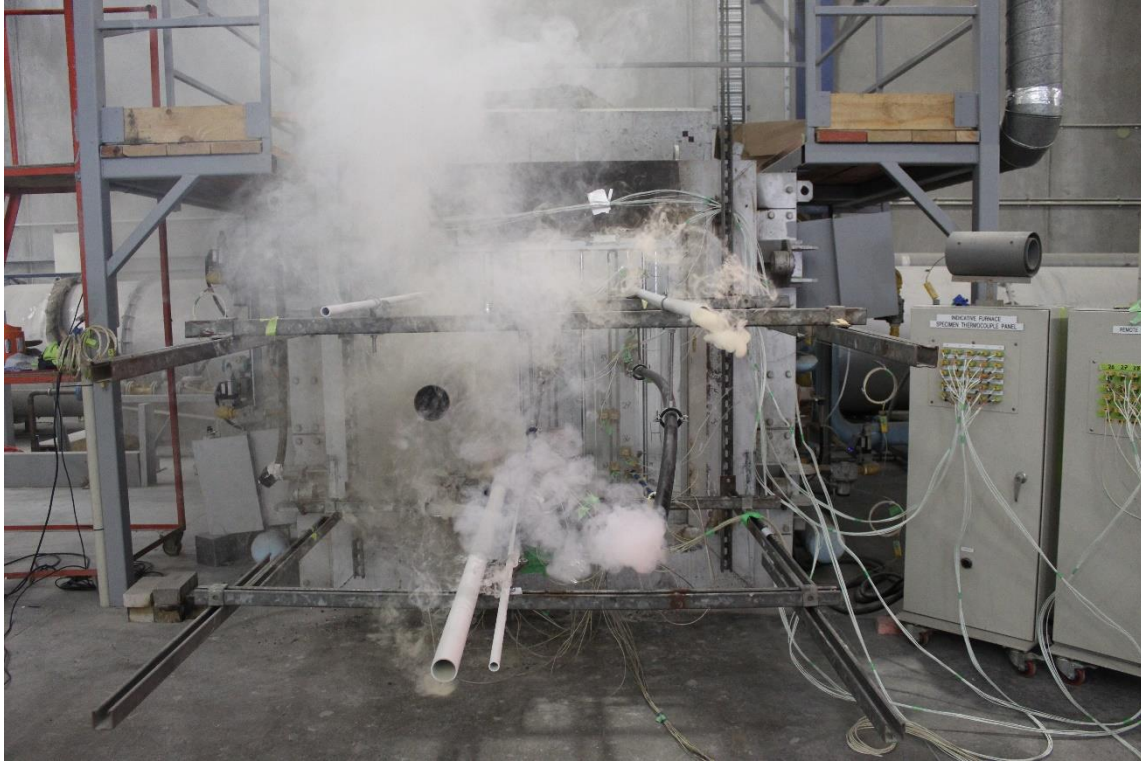
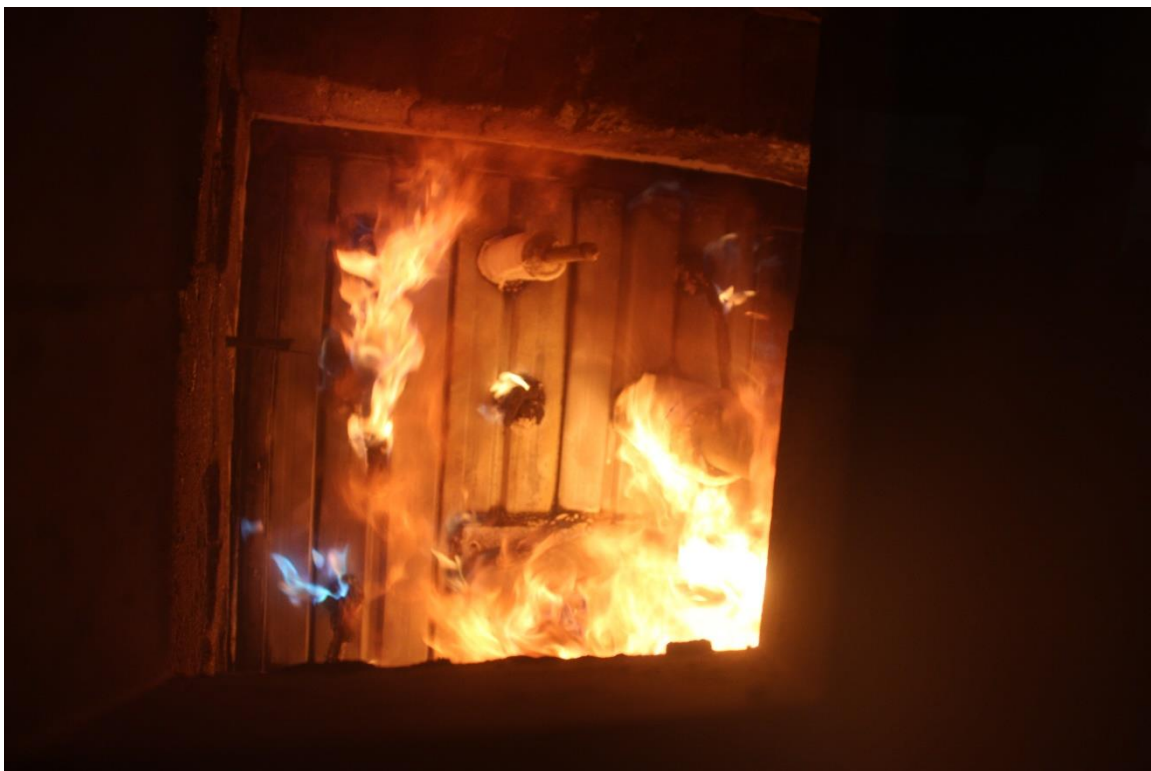
10 minutes:

## 11.2 During and after the test
