Test report # PF21046-A

Issued to: Intex International

Fire resistance tests for wall penetrations

Test method: AS 1530.4:2014

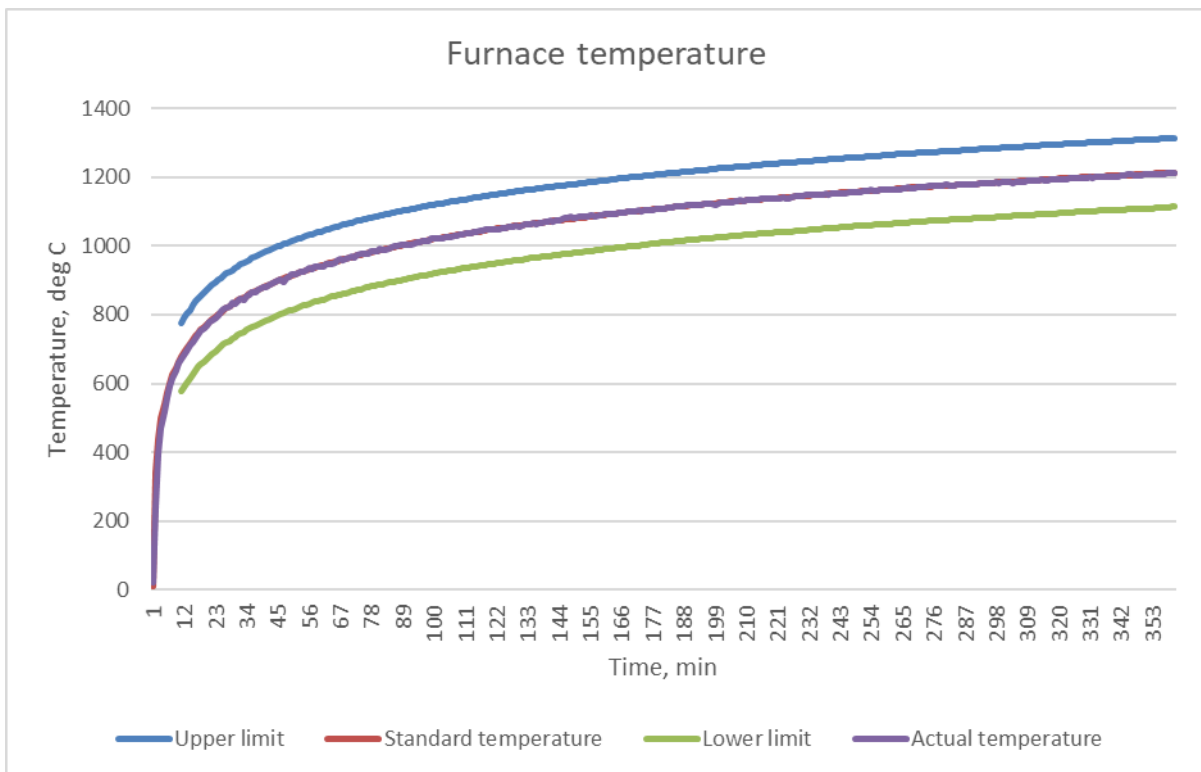
6.1 Furnace Temperature

The furnace was controlled to follow the temperature/time relationship specified in AS 1530.4-2014 as closely as possible.

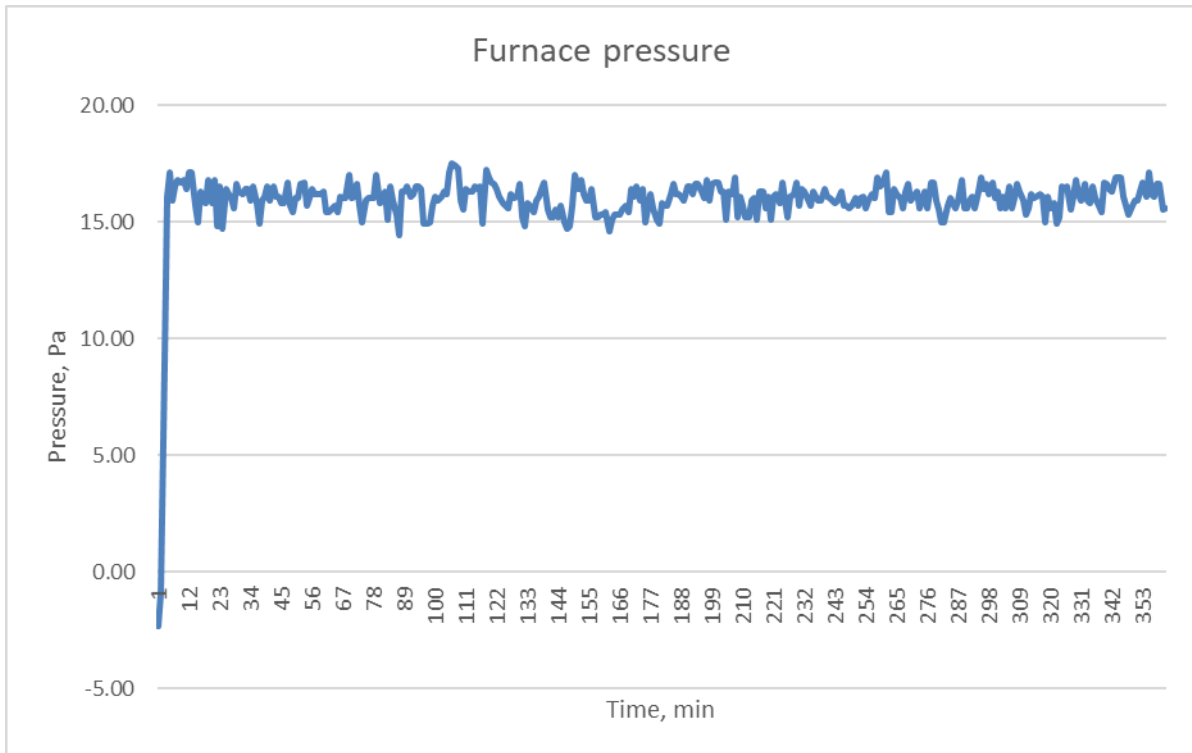
6.3 Pressure Readings

The furnace pressure was maintained at 16 ± 3 Pa with respect to atmosphere. The probe was located 500mm above the furnace floor.

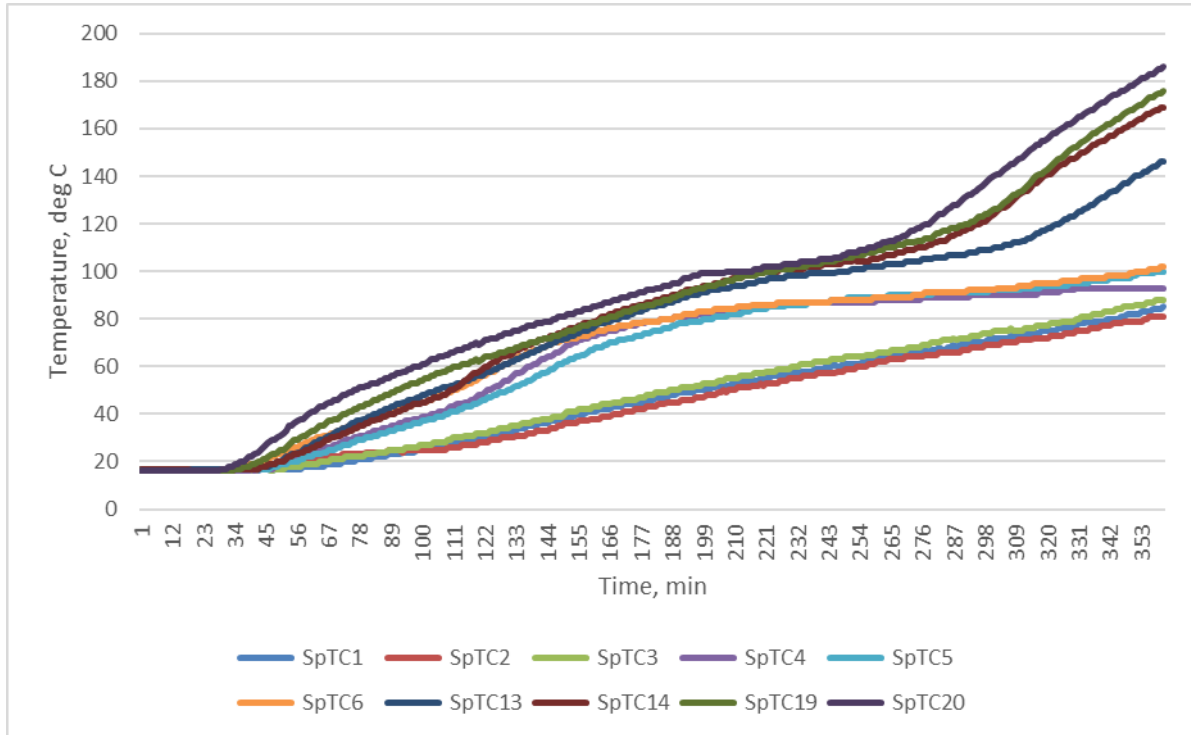
Structural adequacy	Not applicable
Integrity	No failure at 360 min
Insulation	No failure at 360 min

Specimen A Thermocouples Readings

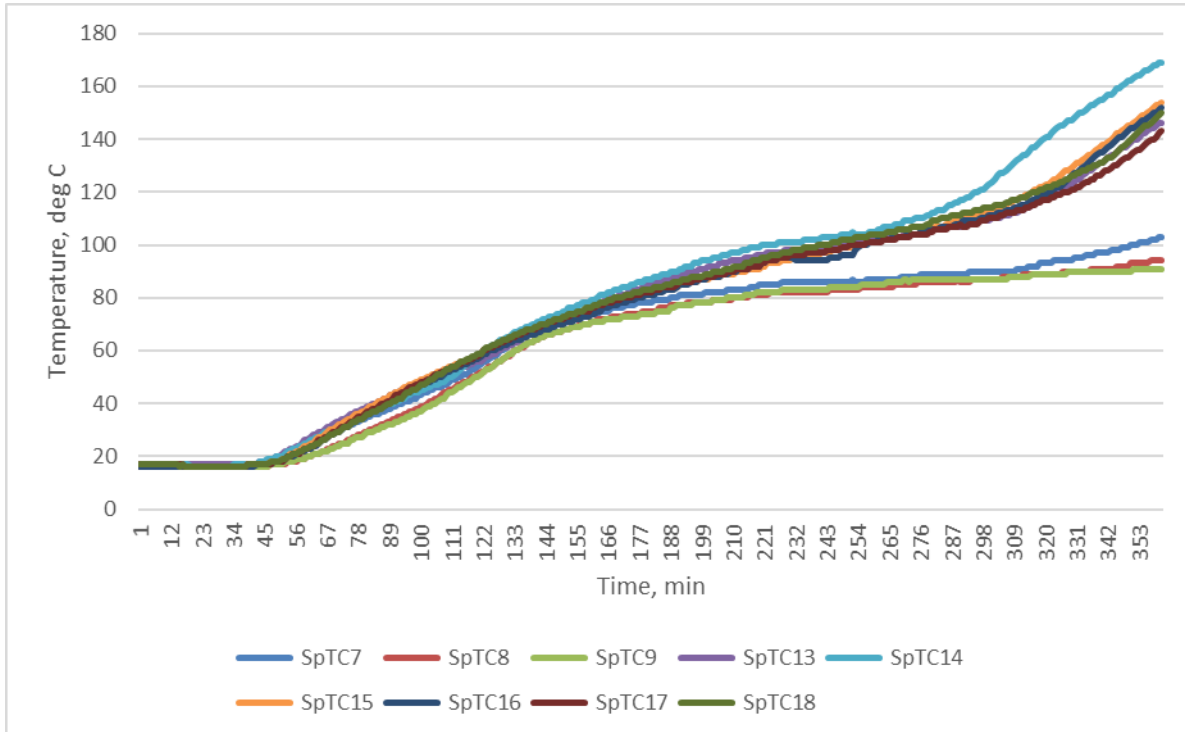
Structural adequacy	Not applicable
Integrity	No failure at 360 min
Insulation	No failure at 360 min

Specimen B Thermocouples Readings

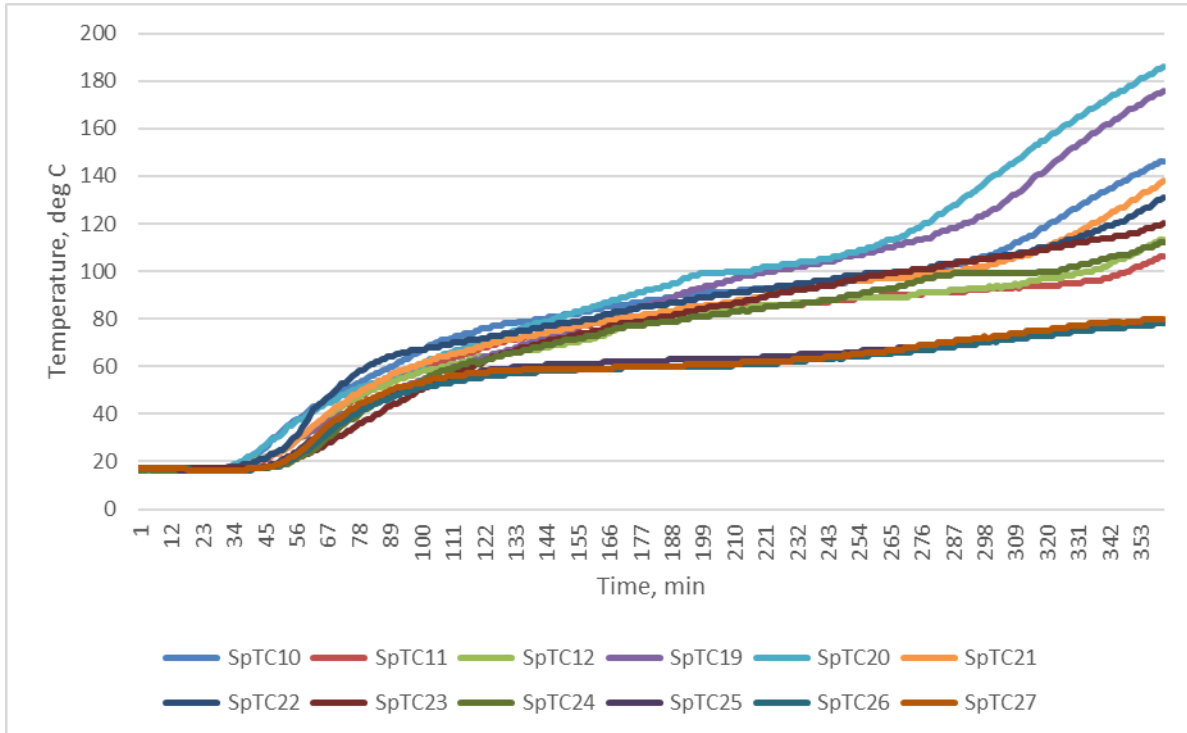
Structural adequacy	Not applicable
Integrity	No failure at 360 min
Insulation	No failure at 360 min

Specimen C Thermocouples Readings

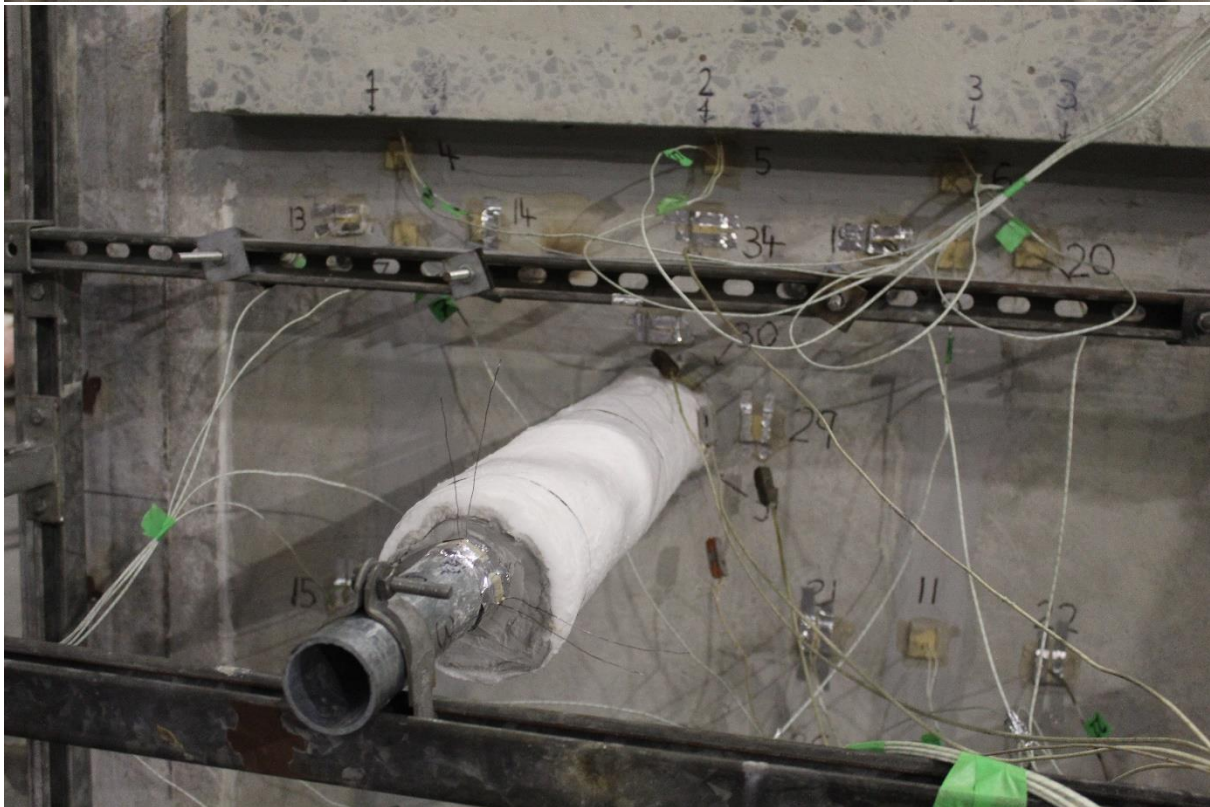
10.4 Specimen D

Penetration System		
D	Service	40DN Steel Pipe
	Service Details	Pipe (2.1), Sealant (3.1), Concrete slab 2 (1.4), Ceramic Fibre Blanket (5.1), Cable ties (4.3)
	Service Support	Unistrut structure at 500mm
	Aperture Size	72.27mm
	Annular Spacing	Min: 6mm, Max: 20mm
Local Fire-stopping Protection		
Application	Symmetrical, capped from exposed face only	
Protection Used	<p>The steel pipe (2.1) was passed through the aperture, extending 850mm from both faces.</p> <p>Ceramic fibre backing was installed in the aperture, recessed 30mm (nominal) from both faces. Sealant (3.1) was applied to the apertures, flush with the separating element. A length of Ceramic fibre was cut and wrapped around the service 2 ¼ times. The ceramic fibre was secured using cable ties (4.3), and extended 610mm from both faces. A 25mm (nominal) radius bead of sealant was applied between the concrete slab and ceramic fibre. Sealant was applied between the end of the ceramic fibre and the pipe to fill any remaining gaps.</p>

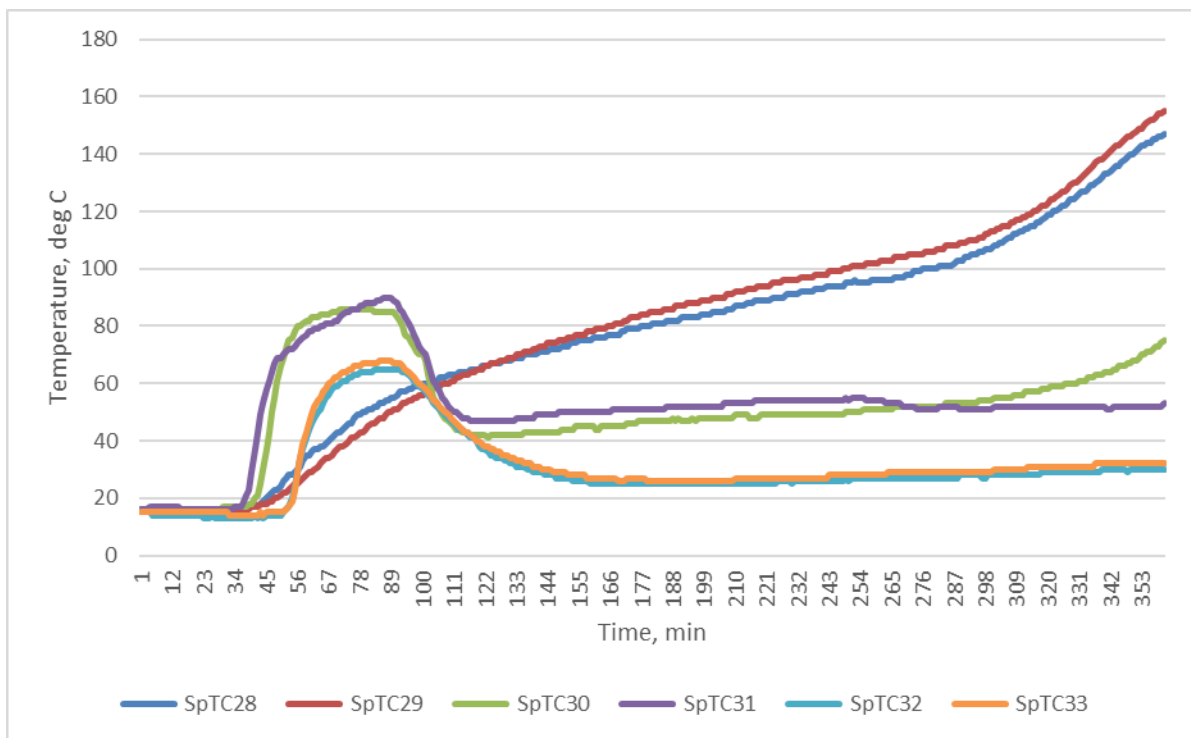
Structural adequacy	Not applicable
Integrity	No failure at 360 min
Insulation	No failure at 360 min

Specimen D Thermocouples Readings
